# Map 07: Booth's Bridge and Keighley Golf Club

## Map 07: Booth's Bridge and Keighley Golf Club

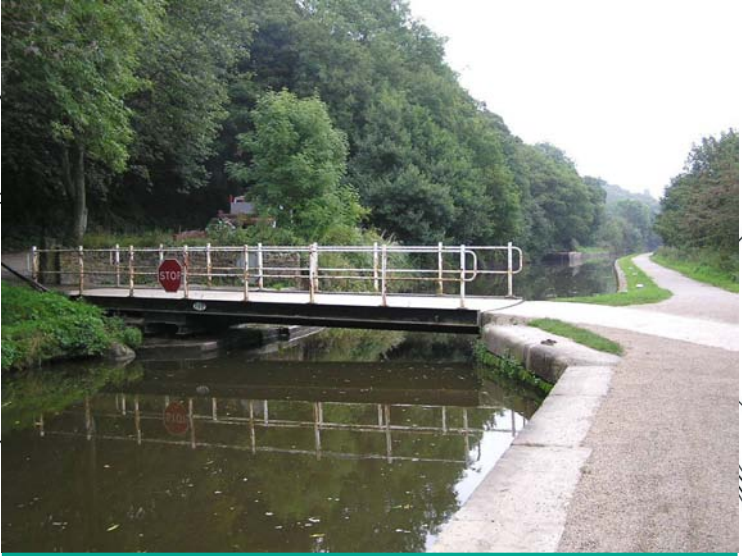
**1. Booth's Bridge (195):** Booth's Bridge is a modern swing bridge that is operated manually from a pivot on the northside of the canal. Shown on the first O.S. map of the district as being a swing bridge, the original timber bridge has long since been replaced with the existing structure. The current bridge is almost entirely of metal construction, having a metal base and handrails. The decking appears to have been covered with a layer of tarmac. The abutments on each side of the canal are coped with stone, as are the moorings that extend down the side of the canal for a short distance to the southeast of the bridge.

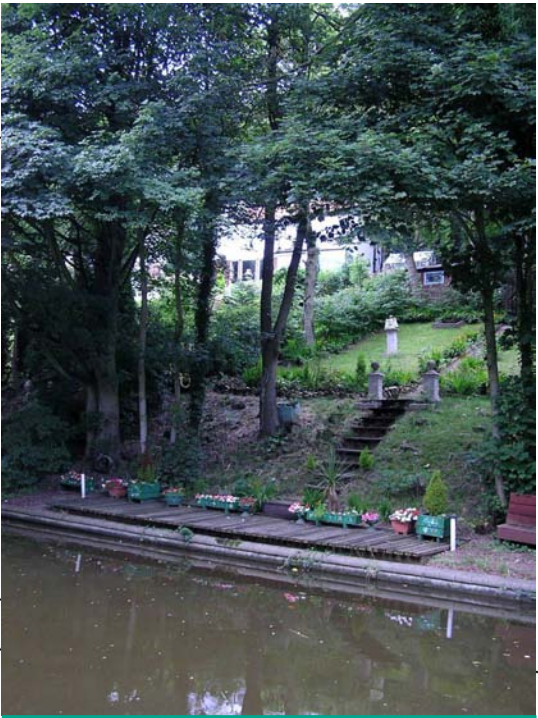
A wharf at the foot of a domestic garden at Elam Wood Road. The trees are an important feature of this area.

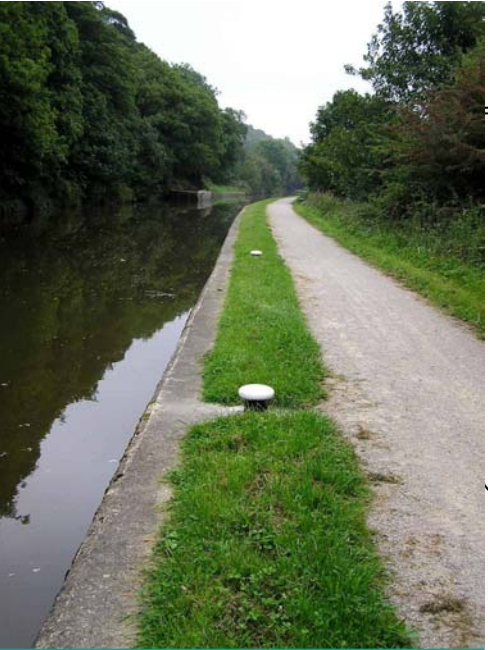
The concrete canal bank at the edge of Riddlesden is out of place in a rural scene such as this.

- ▶ The lime kiln alongside Booth's Bridge is in poor condition and requires some maintenance and removal of trees from its roof to halt further damage to the historic fabric.
- ▶ Concrete copings to the edges of the canal and particularly around the overflow have a negative visual impact.
- ▶ Overgrown and overhanging vegetation alongside the towpath needs regular cutting back.

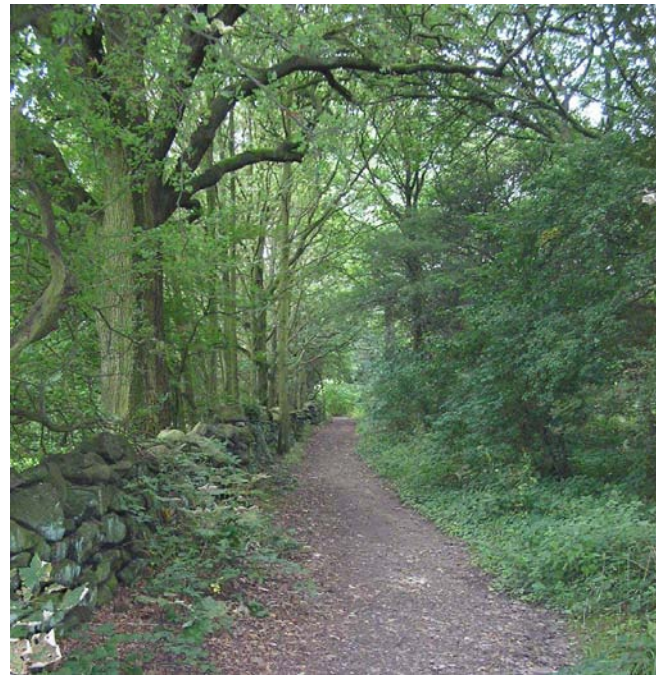
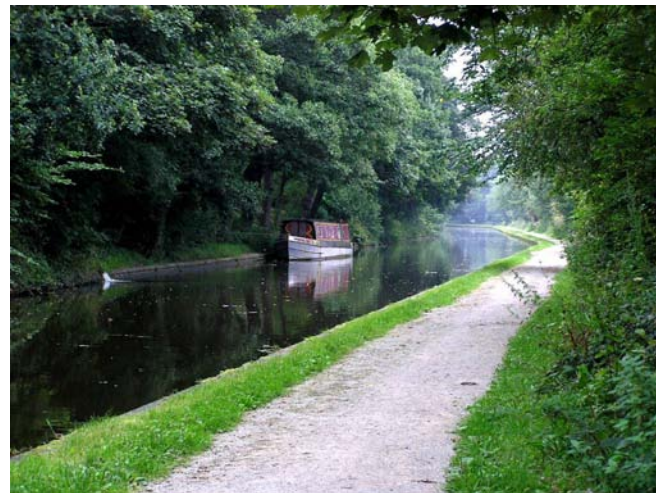
The area around Booth's Bridge is dominated by trees and foliage which hem in both the canal (above) and the tracks which lead to the bridge (top).

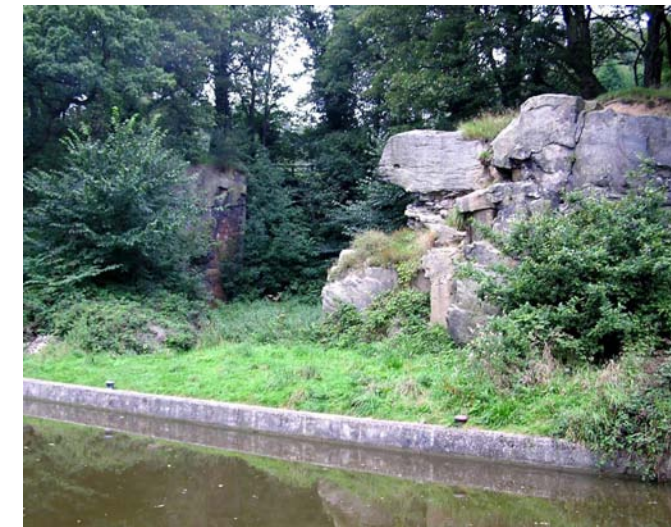
**3. Carr Delph:** To the south of Riddlesden Golf Course Club-house is an area known on the maps as Carr Delph. This area contains a number of sandstone escarpments, some of which stand immediately alongside the canal and appear to have been quarried in the past. A line of concrete coped moorings along this section of the canal indicates that stone was taken directly from the quarries onto the boats.

Top Right: Carr Delph: one of the few former quarries alongside the canal in the conservation area.

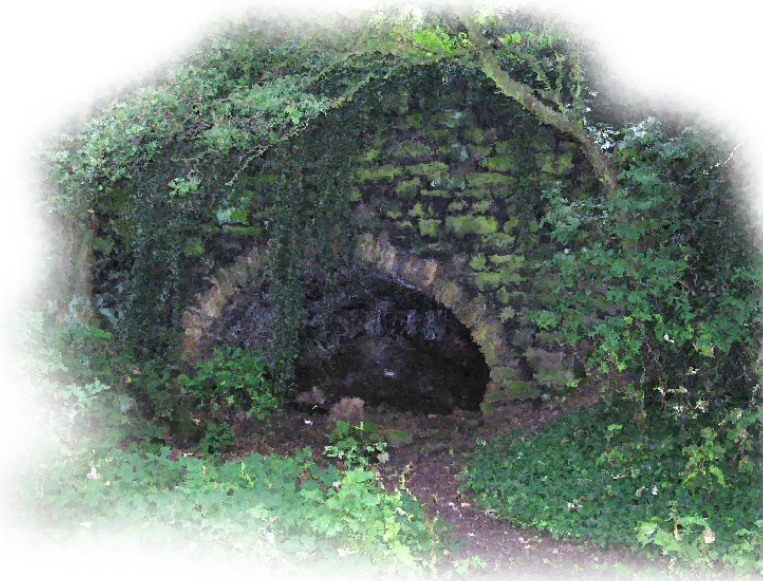
**2. Lime Kiln, Booth's Bridge:** Set in the banks of the canal on the south side of the waterway is a single lime kiln. The kiln is accessed via a rough, rocky path that leads off the towpath into an area of dense woodland on the edge of Keighley Golf Course. The kiln was probably built contemporarily with or shortly after the construction of the canal and therefore may well date to the late 18th century. The kiln is built of rubble stone and has an arched opening defined by dressed voussoirs that leads to an arched roof space with an opening at the back for the flue. Now in poor condition with trees growing out of the roof of the kiln, the future of the structure is uncertain unless maintenance work is undertaken.

Illustration: The 18th century lime kiln near Booth's Bridge is overgrown and neglected.
