Map 11: Area to east of Swine Lane and west of Morton

Character of the Area

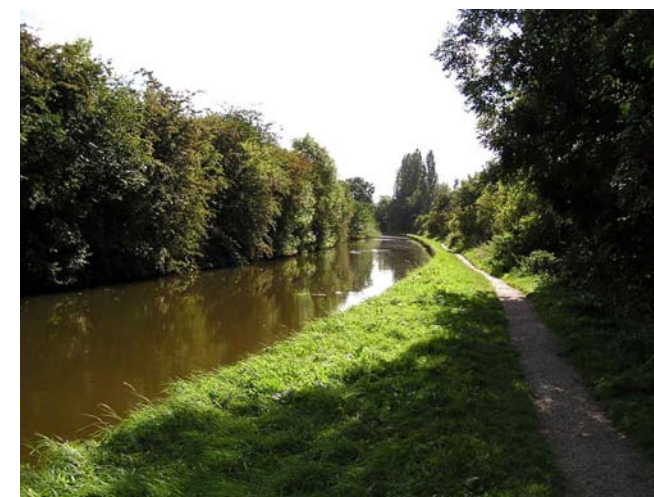
Far Left: Potentially built during the Second World War, this waterstop was one of 80 along the canal. In the case of a serious breach the timbers stored by the towpath would be slotted into the rebates set into the banks of the narrowed canal in order to stop water from flowing to the area where the breach has occurred.

1. Waterstop, Sandbeds: The banks of the canal close in at this point, narrowing the waterway down to half its normal width. Located alongside on the edge of the towpath is a pile of long, heavy timbers that are intended to act as a barrier to halt the flow of the water. The purpose of this feature was to isolate sections of the canal should there be a serious breach of the banks. Many of these water stops were constructed during the Second World War to potentially minimise water loss and damage should the canal have suffered a direct hit from a bomb.
