Conservation Area Appraisal

Micklethwaite

June 2009

City of Bradford MDC

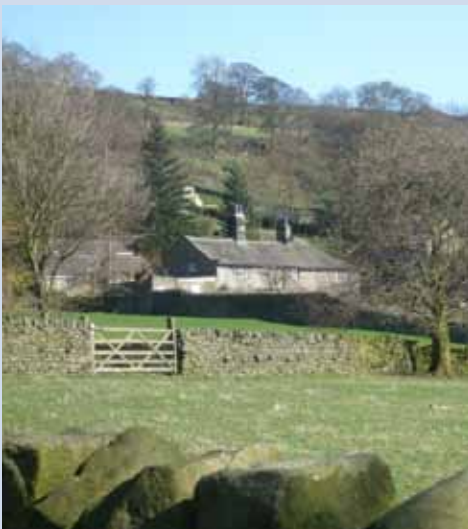
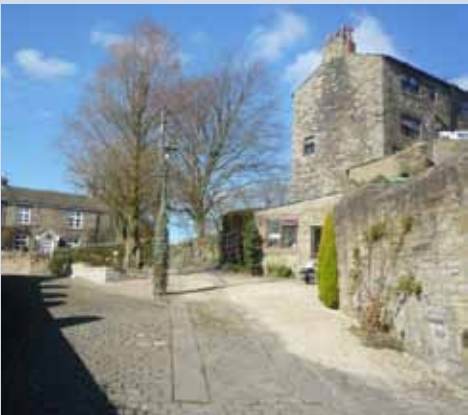
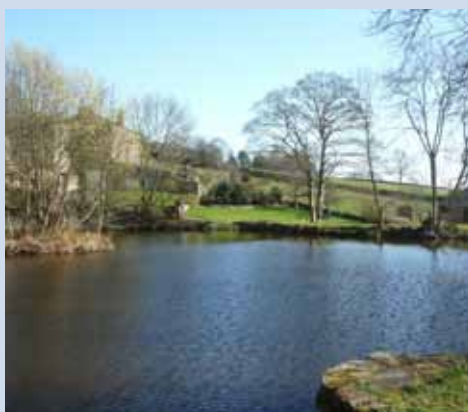
Top: Pastoral fields around Micklethwaite Grange with Micklethwaite Bank in the background.

Middle: Street scene at Beck Road.

Bottom: Holroyd Mill pond - an attractive water feature.

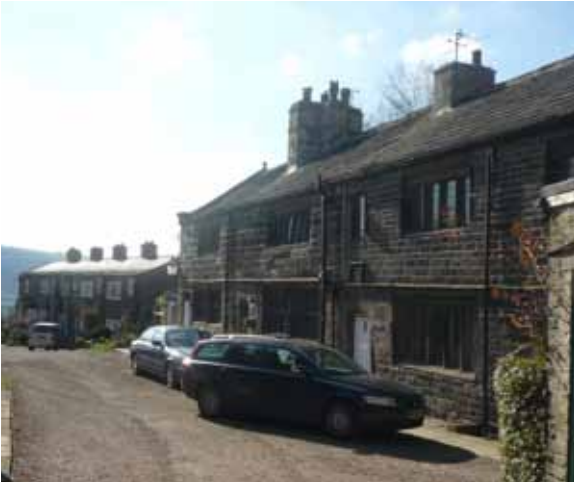
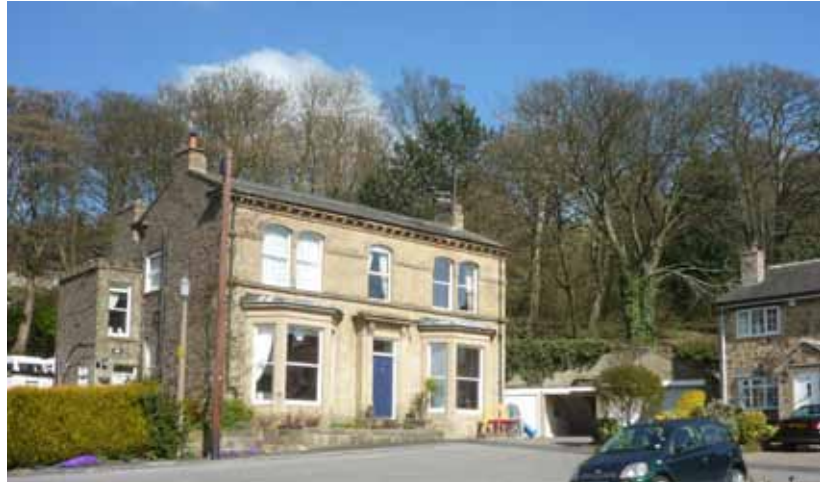
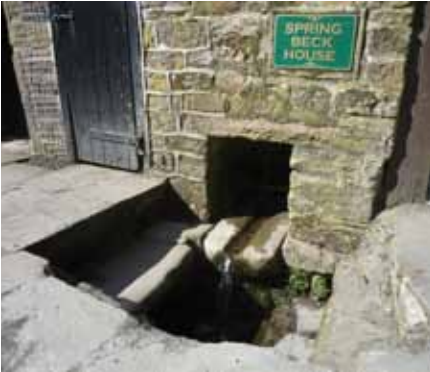
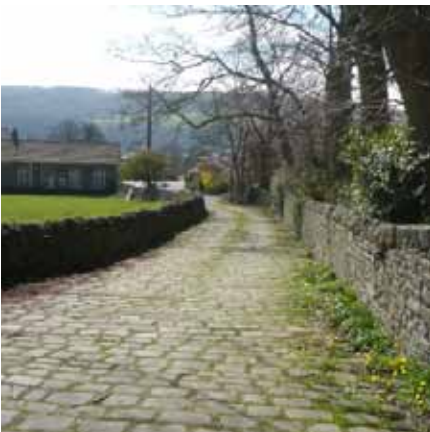
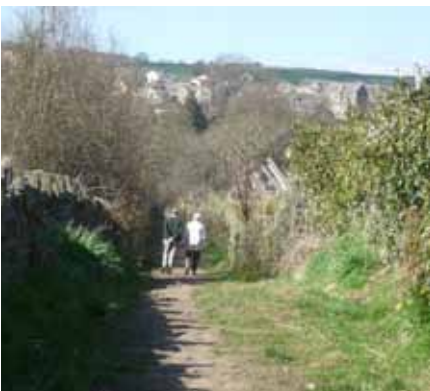
From top right and left: Traditional buildings, materials and details at Thornfield House (right) and Victoria Street (left); The well at Spring Beck; Stone setted surface at Butlers Fold; Footpath at Acre Lane leading down to Morton Beck.

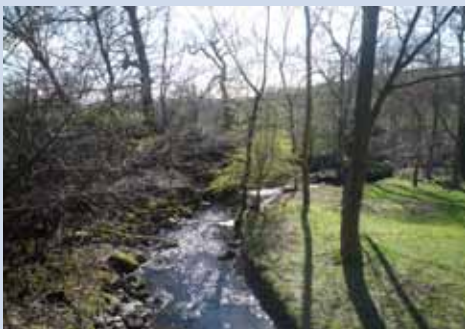
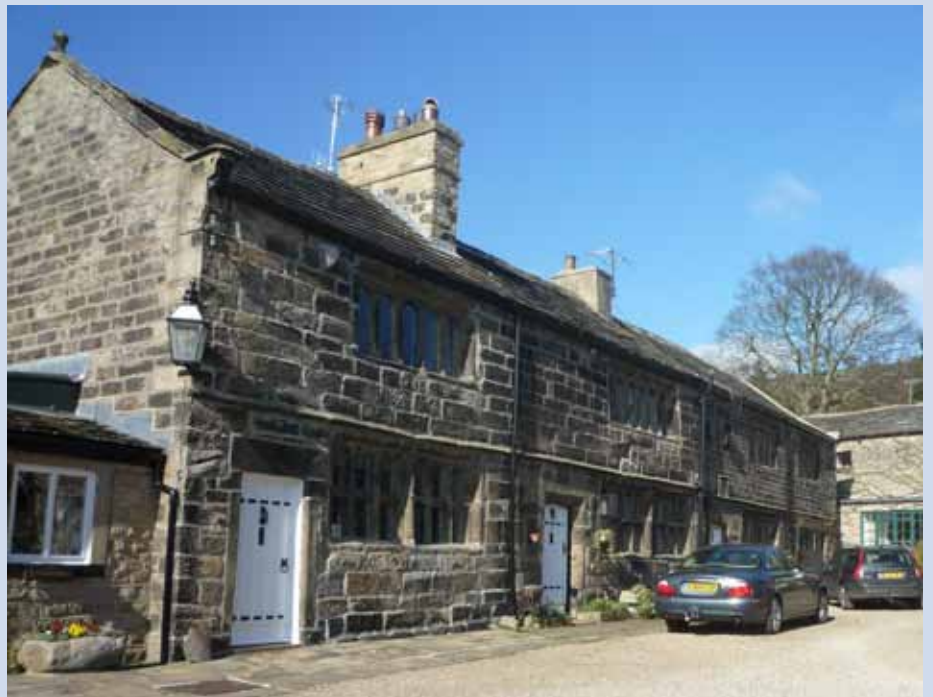
*Below left: Morton Beck;
Below: The buildings at numbers 4 - 10
Victoria Street have retained many of their
traditional features*

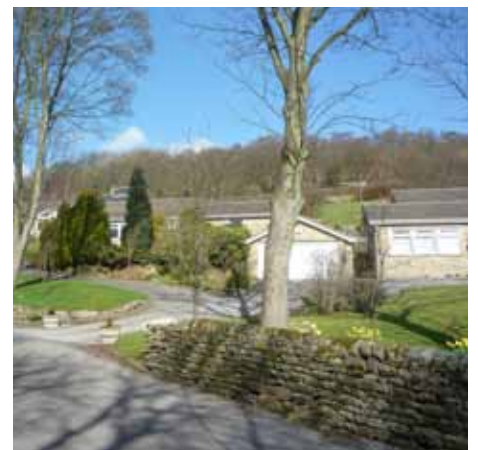
*Modern suburban development along
Micklethwaite Lane*

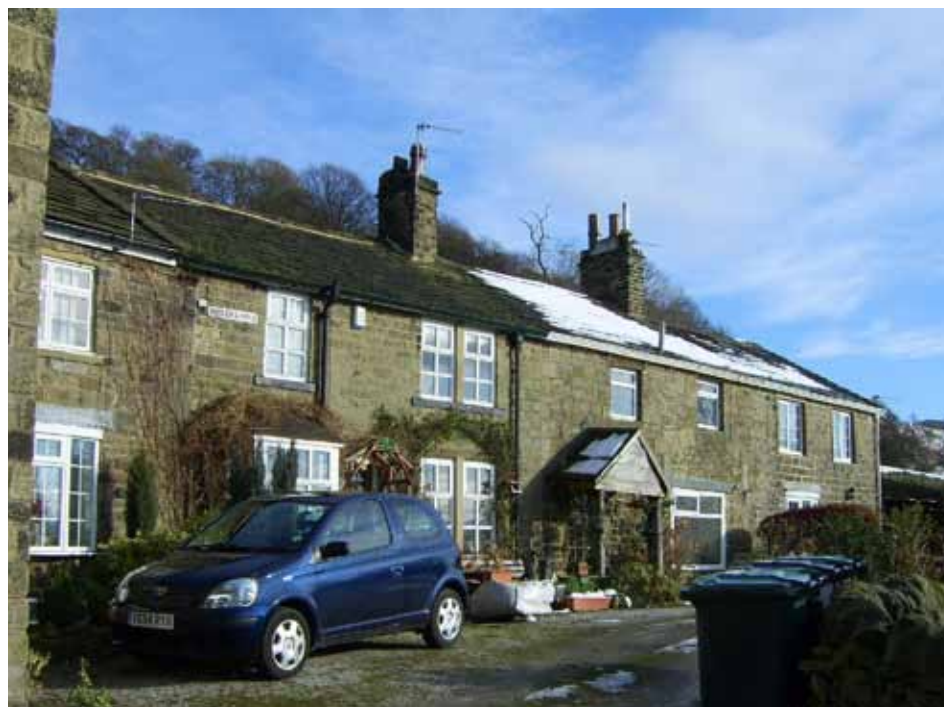
Loss of traditional features and inappropriate alterations to historic properties at Butler's Fold.

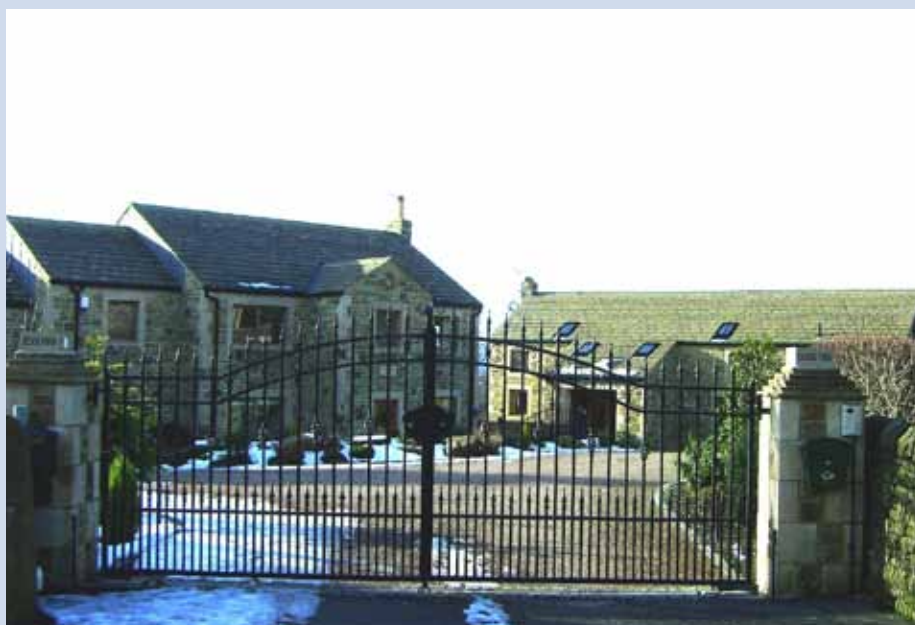
Thornfield Farm – A collection of modern farm buildings which didn't contribute to the character of the conservation area have been demolished and replaced by two stone built dwellings (Canal View and Moor View) and associated garden areas.

NEUTRAL IMPACT

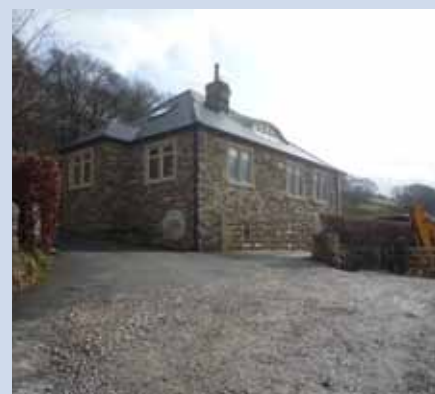
The Bungalow, Micklethwaite Lane – The former bungalow on site didn't contribute to the character of the conservation area and has been demolished and replaced by a new dwelling of similar size and position.

NEUTRAL IMPACT

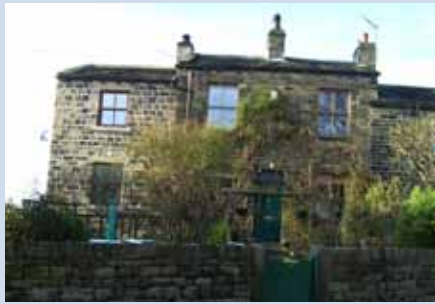
5 Appletree Cottages, Micklethwaite Lane – a two storey side extension has been added to this 19th Century cottage. The design and materials are generally sympathetic to the original building.

NEUTRAL IMPACT

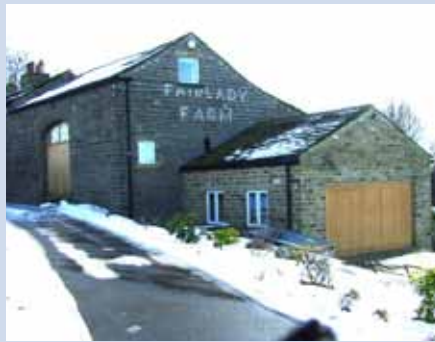
Fairlady Farm – a number of changes have occurred to this range of buildings:

- the timber sash windows in the garage extension have been replaced by UPVC windows;
- the barn has been converted to residential use, and;
- a leanto at the eastern end of the range has been demolished and rebuilt.

Overall these changes are sympathetic to the historic character of the building although the modern windows let it down.

NEUTRAL /NEGATIVE IMPACT

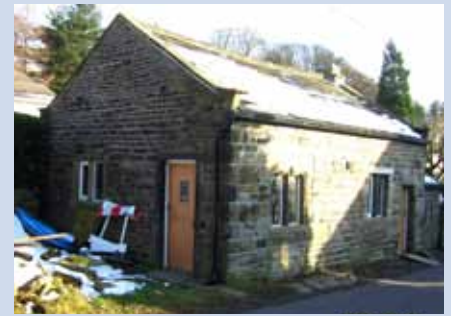
Store/workshop east of 21 Micklethwaite Lane – Work is currently underway to convert this key unlisted building into a dwelling. The reuse of this building should have a positive impact on the character of the conservation area. However there is concern regarding the appropriateness of the work, particularly the modern window details which look out of place on this building which is thought to date from the 17th Century.

POSSIBLE NEGATIVE CHANGE
