Conservation Area Appraisal

Silsden

April 2006

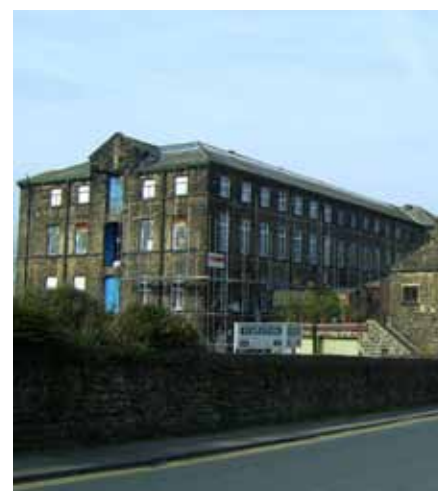
Waterloo Mills is a prominent reminder of Silsden's industrial past.

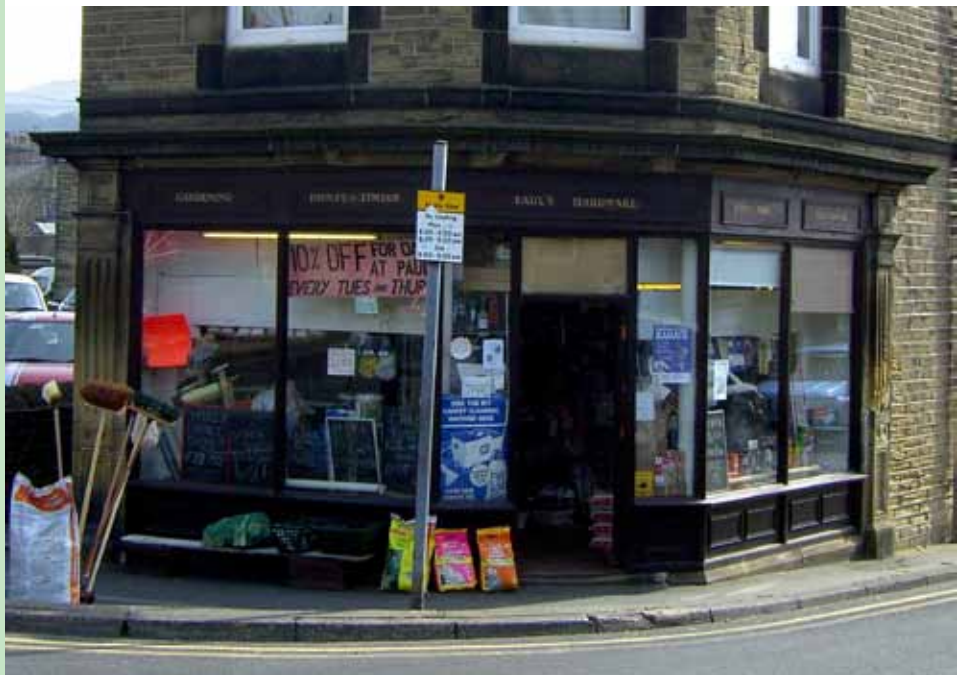
Well detailed traditional shopfront at 26 Briggate

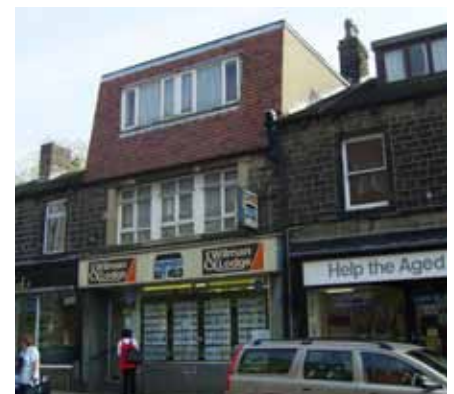
Inappropriate shopfront and dormer window on 70-72 Kirkgate

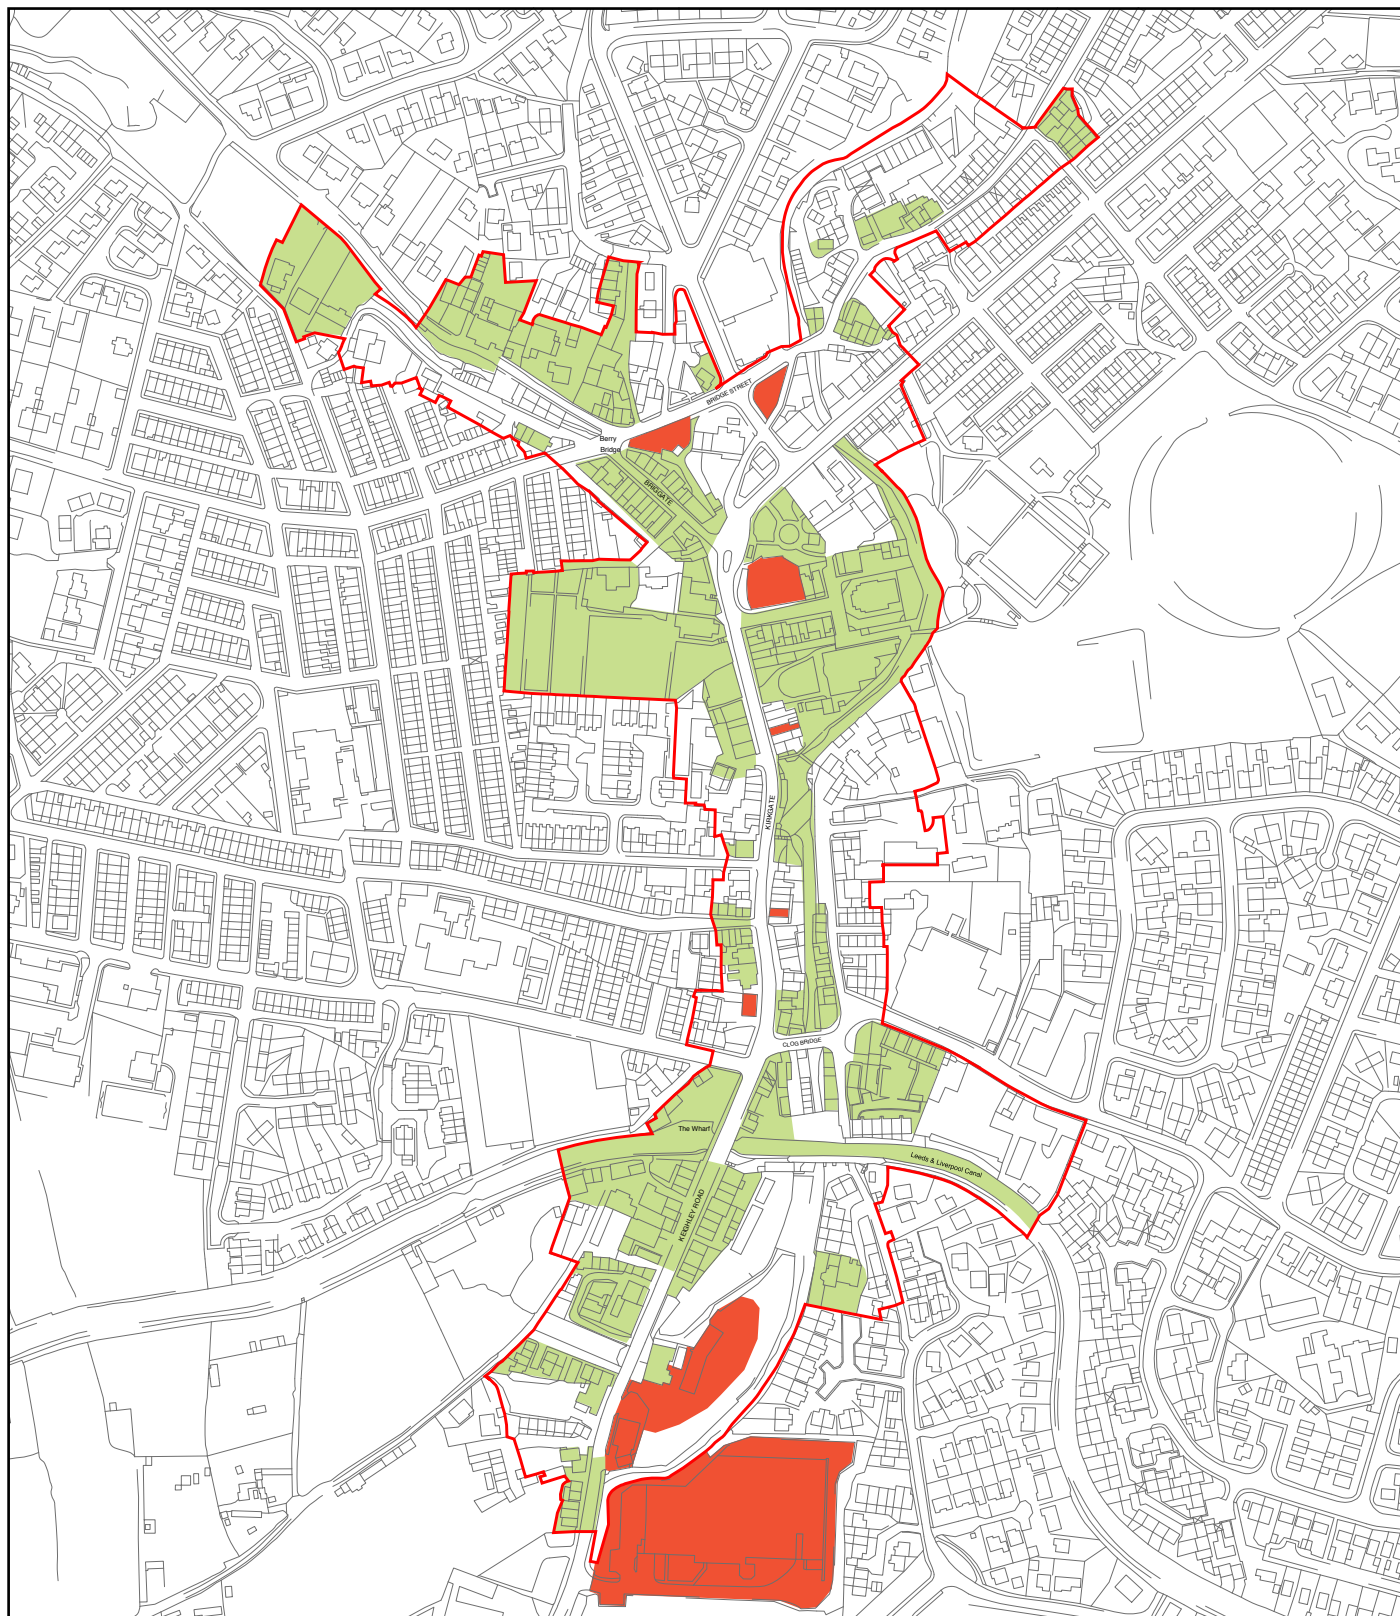
Character Contributions

NB The 'positive', 'negative' and 'neutral' areas relate to the contribution the site/building currently makes to the character of the Conservation Area. The classification in no way means that the site/building has no special architectural, historic or archaeological interest.

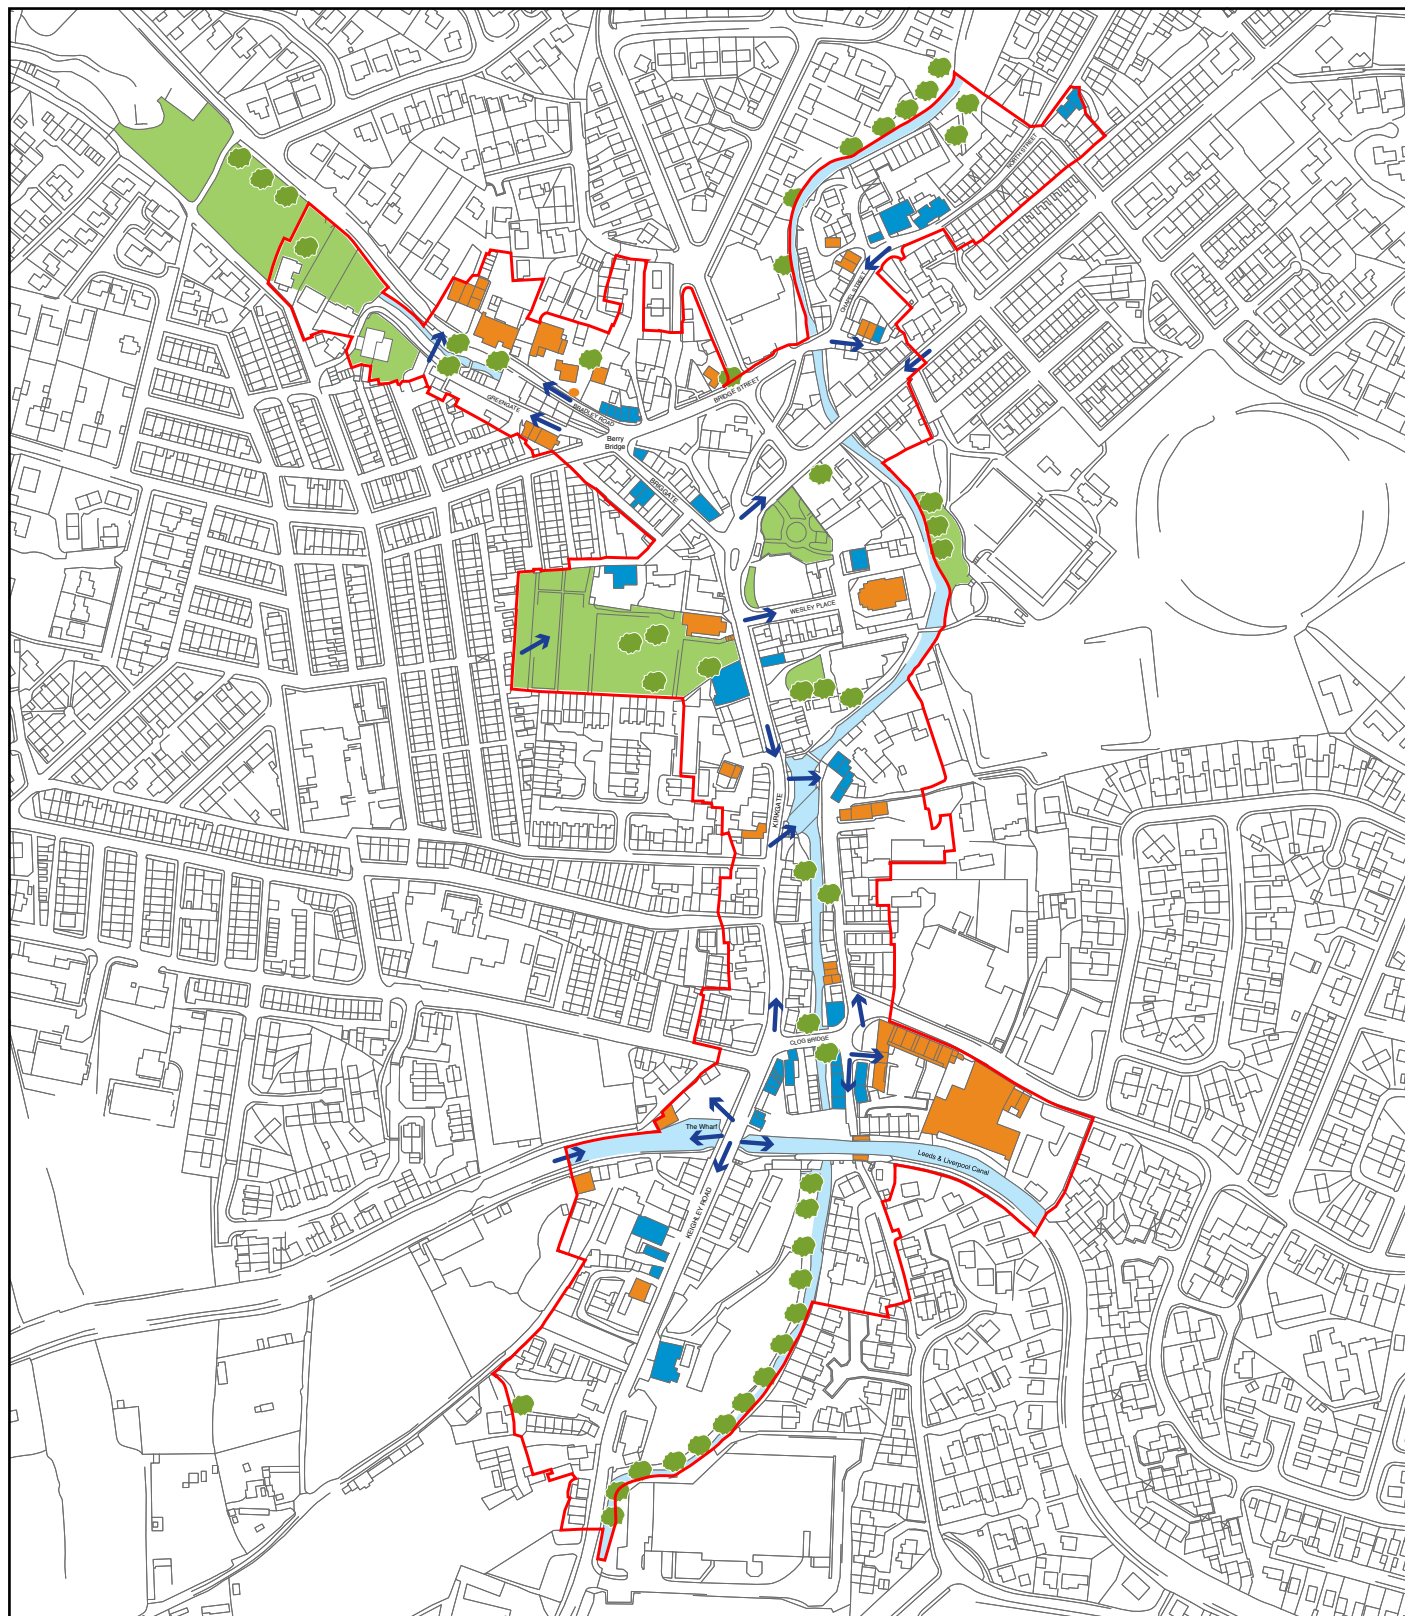
Open Spaces, Trees, Views, Listed and Key Unlisted Buildings

NB This map does not identify key trees individually, but merely indicates where there is at least one important tree.

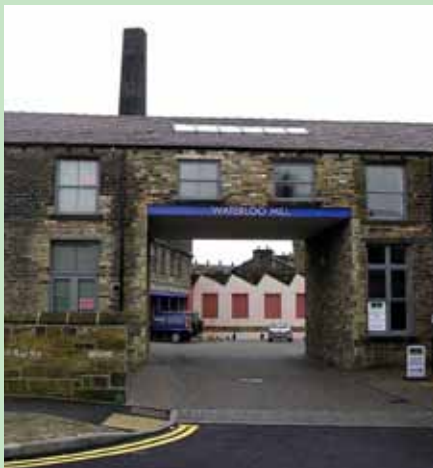
Waterloo Mill, a key listed building in the conservation is currently subject to a major residential scheme involving the conversion of the mill and associated cottages to residential and the construction of a terrace of six dwellings alongside the canal. The scheme is in its final stages of completion and maintains the industrial character of the mill.

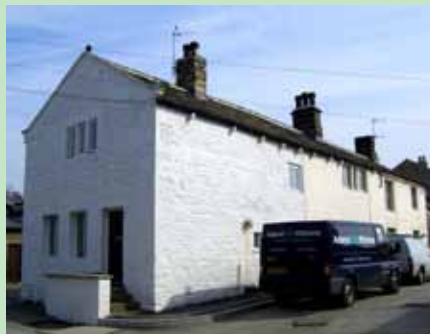
The renovation and conversion of **Grade II listed agricultural worker's cottages on St John's Street** is underway at time of writing. The scheme involves extensive internal alterations, new windows and repair works to the roofs. Works are in the early stages but have the potential to have a positive impact.

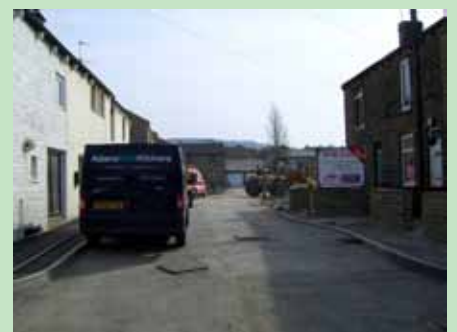
The land to the rear of St John's Street has approval for the construction of 11 eleven houses. These will necessitate the loss of some older farm buildings that have been extensively altered and the demolition of several modern industrial units. The scheme looks well detailed and has the potential to make a positive impact on the conservation area.

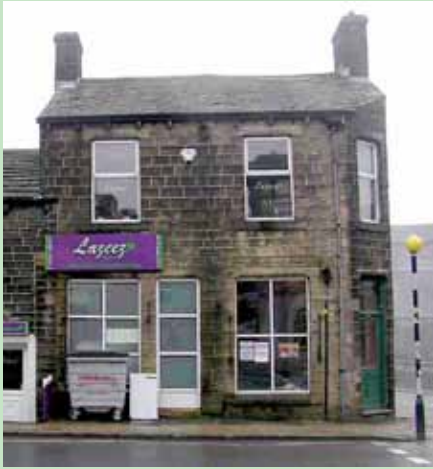
An application for an illuminated sign on nos. **8-10 Kirkgate** was approved on appeal in 2005. The sign is untraditional in appearance and does not maintain the character of the conservation area.

NEGATIVE IMPACT

Lesson: The earlier adoption of Design Guidance for Shopfronts may have strengthened the Council's position at appeal.

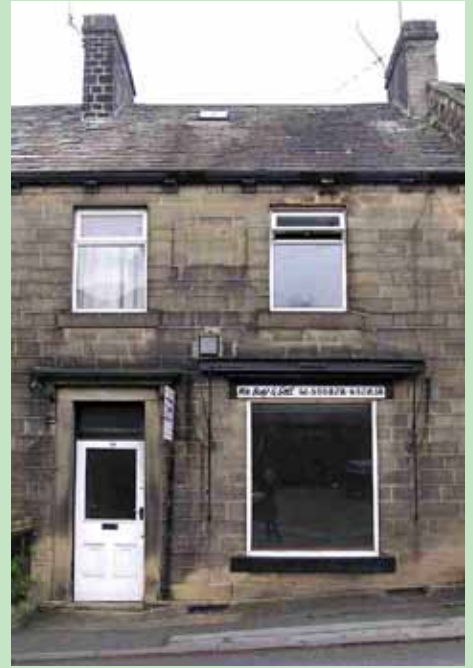
Vacant shop at 19 Bolton Road
