## Conservation Area Appraisal

# Bingley

October 2006

City of Bradford MDC

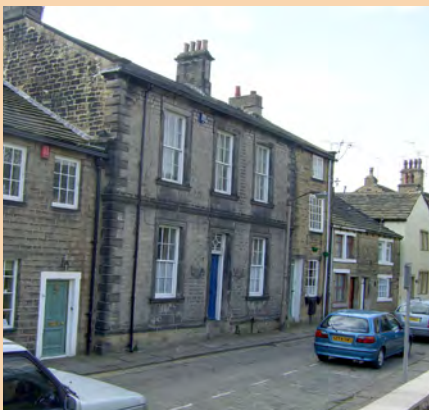
Well detailed buildings on Old Main Street.

Well detailed shopfronts and traditional window details such as those at 91-93 Main Street contribute to the character of the conservation area.

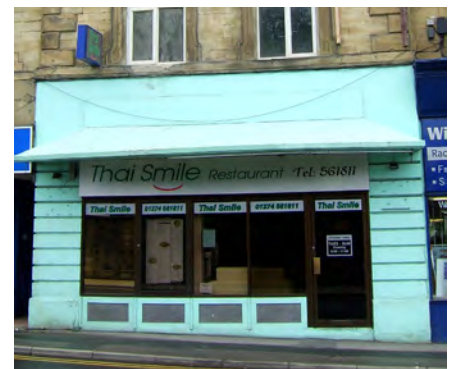
Altered shopfront on Main Street.

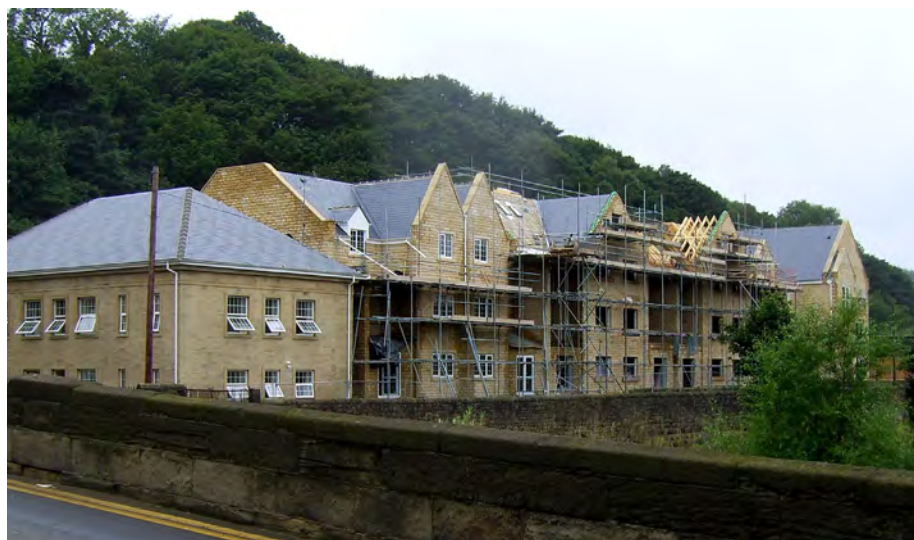
*Development in progress alongside the River Aire.*

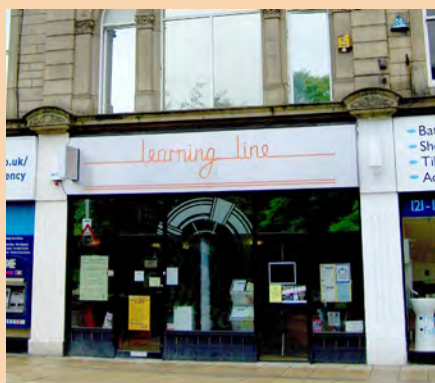
The former shop at **119 Main Street** has been converted to a training centre for Shipley College. The building maintains the appearance of a retail unit but is not traditional in design or style.

### NEGATIVE CHANGE

**Lesson:** In future applications should specify a higher standard of design and materials before approvals are issued.

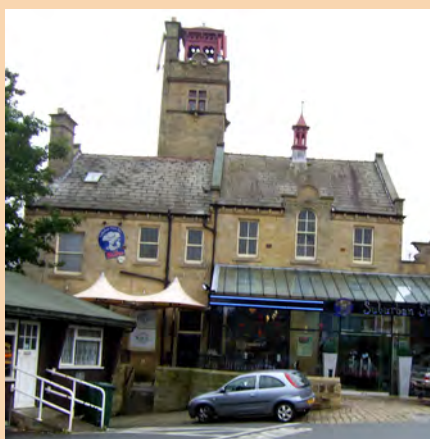
Two applications have been approved for works to the Grade II listed **Old Fire Station (now Suburban Style Bar) on Market Street**. A canopy has been erected on the terrace and telecommunications equipment mounted on the building. Both have failed to enhance or preserve the character of the building or the conservation area.

### NEGATIVE IMPACT

**Lesson:** Applications, particularly involving listed buildings should be viewed carefully to ensure alterations do not detract from the character of the building.

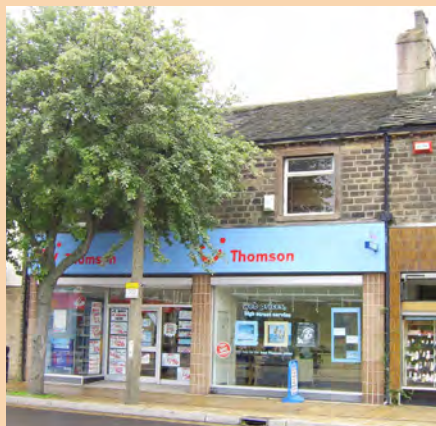
An internally lit fascia sign and projecting sign, both constructed from plastic were granted consent at **109-111 Main Street**. The use of untraditional materials and corporate logos has resulted in a poor result.

#### NEGATIVE IMPACT

**Lesson:** In future applications should specify a higher standard of design and materials before approvals are issued.

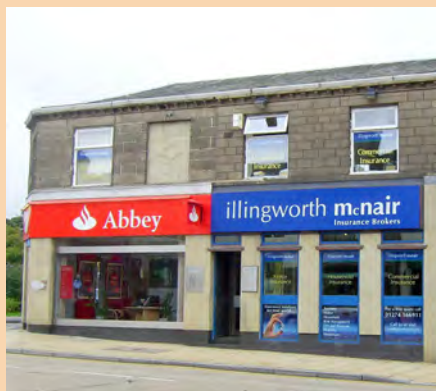
Fascia and projecting signs at **162-164 Main Street** were given consent in 2005. The signs are too big and are entirely modern in their materials and style.

#### NEGATIVE IMPACT

**Lesson:** In future applications should specify a higher standard of design and materials before approvals are issued.

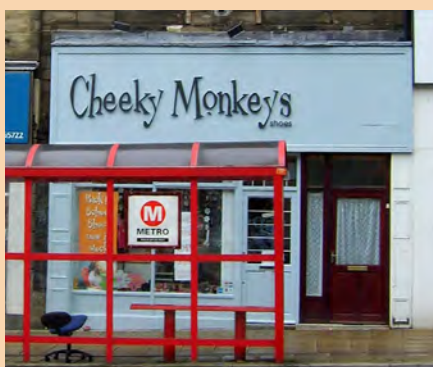
#### NEUTRAL CHANGE

**81 Main Street** has been converted from an office into a children's shoe shop. The shopfront is generally acceptable though the fascia is too large.

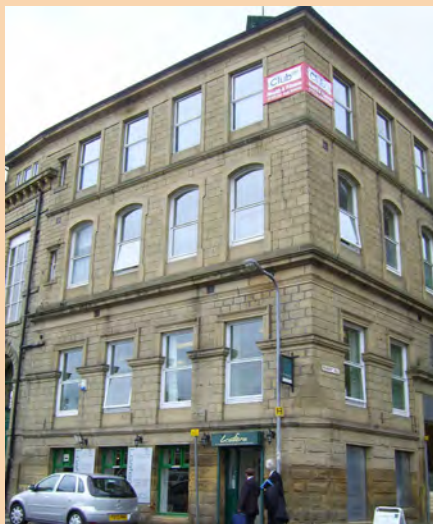
#### NEUTRAL CHANGE

Permission was granted for the change of use of part of **Arden House on Wellington Street** to form a Pilates studio. As there have been no outward changes to the building it has had a minimal impact on the character of the conservation area.

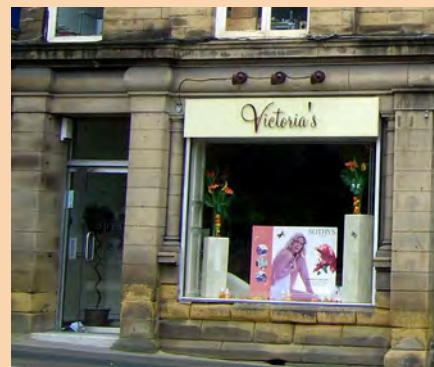
#### NEUTRAL CHANGE

The former shop at **98 Main Street** has been converted into a beauty therapy shop. The shopfront is acceptable and generally the result has been acceptable.

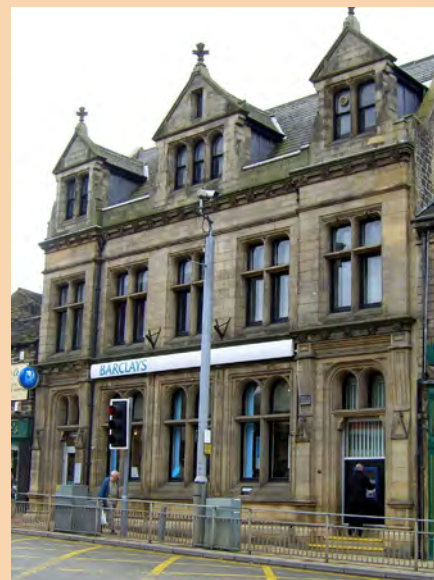
#### NEUTRAL CHANGE

Disabled access has been provided to the bank at **152 Main Street**. The alterations have had a minimal affect on the building's frontage.

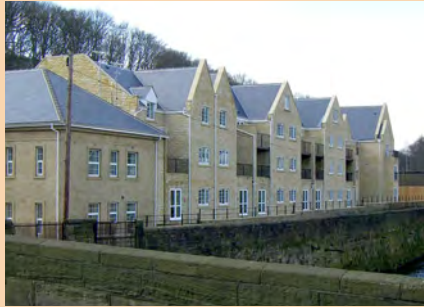
**POSITIVE CHANGE**

**Riverside Works** on Ireland Street is currently undergoing redevelopment with the existing office building being converted into 4 apartments and a three-storey block of 32 apartments being constructed to the rear, just outside the conservation area. It is too early to assess the full impact on the setting of the conservation area.

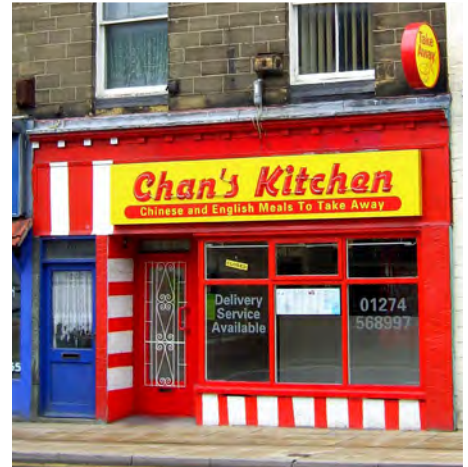
*Right: Altered shopfront on Main Street, which detracts from the streetscape.*

look to ways of mitigating these works and will actively discourage the occurrence of similar situations arising within the conservation area in the future. Design guidance on repair and maintenance of historic properties will be made available.

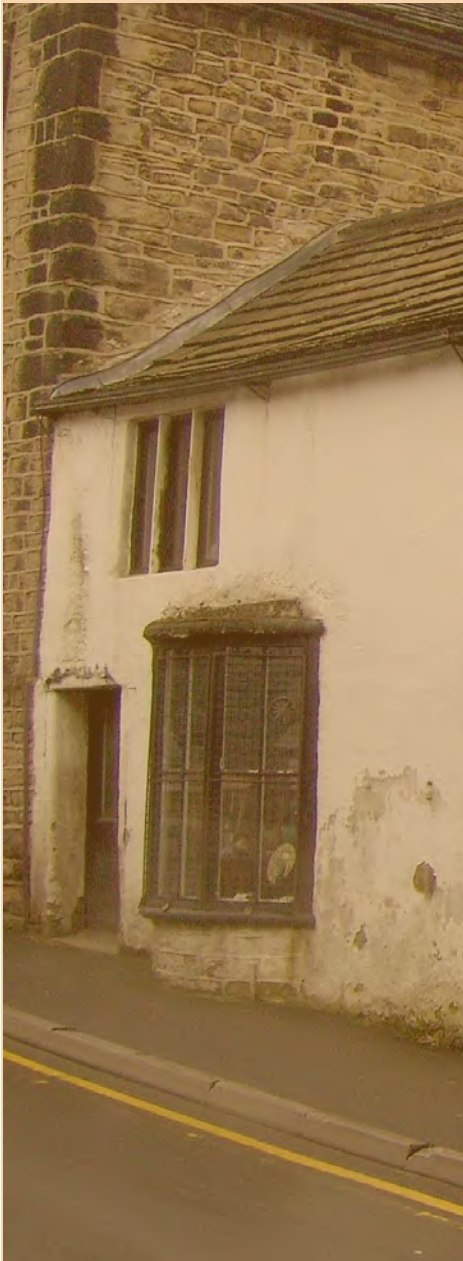
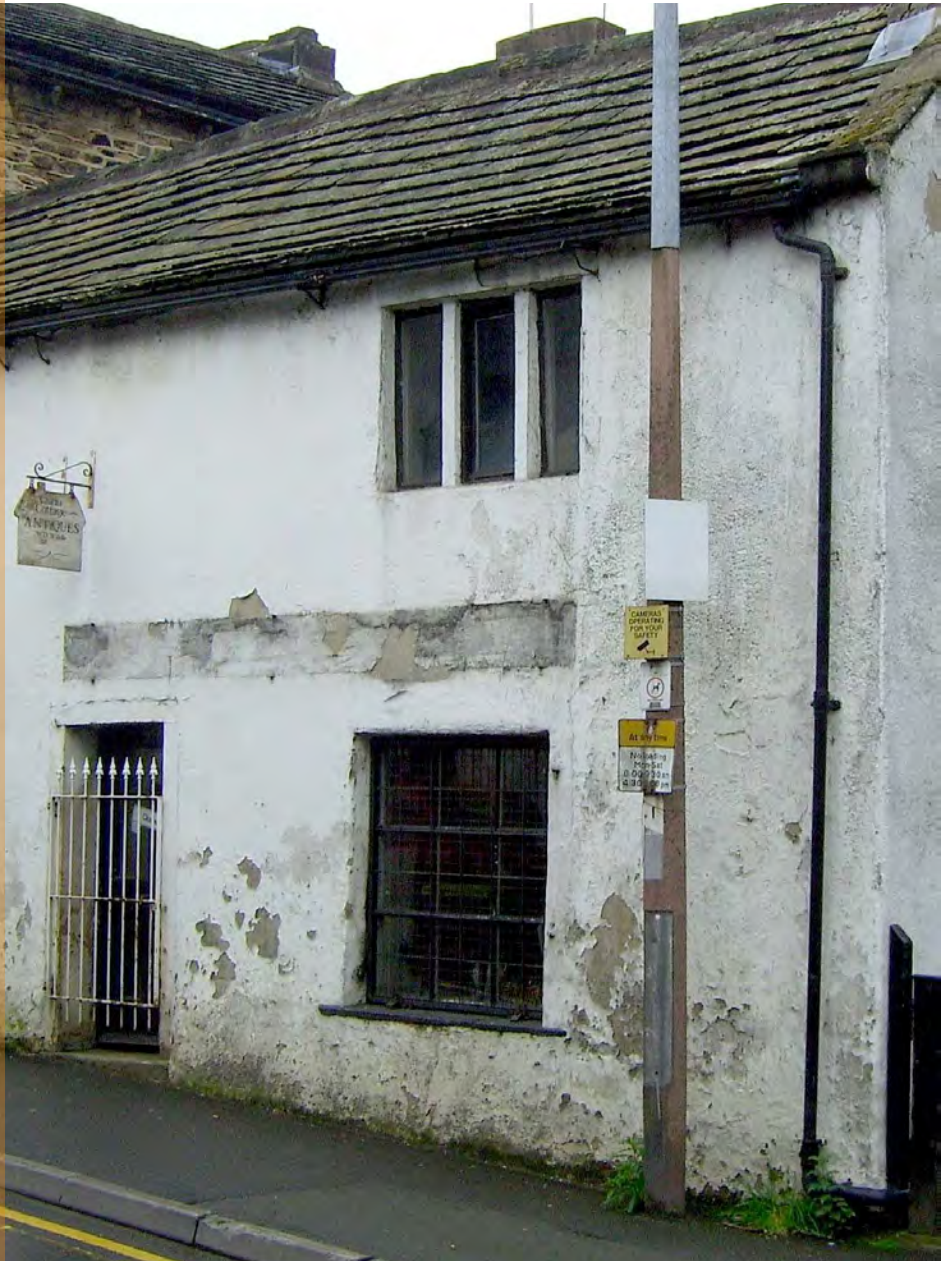
*Below: No's 1-3 Millgate are historic properties in a poor state of repair.*
