## Conservation Area Appraisal

# Thornton

**December 2006**

**City of Bradford MDC**

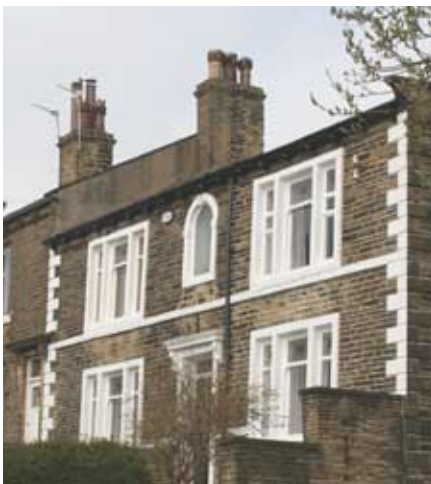
- The use of inappropriate mortar, pointing, the painting of stonework and clutter are undermining the group value and historical character of buildings.
- Few traditional door and window details remain in situ.
- On average, the listed buildings in the conservation area scored only marginally better than the unlisted buildings in terms of authenticity.
- Small minority of vacant or underused buildings and sites.
- More traditional chimneys have been inappropriately altered or removed than in most other conservation areas surveyed in the district so far.
- The replacement of traditional rainwater goods with inappropriate modern ones.
- The inappropriate alteration or removal of traditional boundary features are harming the street scene.
- A minority of traditional shopfront details remain in situ.

*Left: Painting of stonework undermines the historic character of a conservation area.*

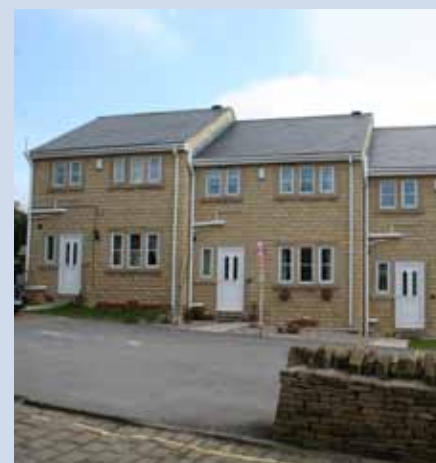
The terrace of three houses at **14-18 Sappgate Lane** was completed c.2004. The houses are built from artificial stone with slate roofs and uPVC windows and are fronted by an open area of parking.

### NEGATIVE CHANGE

**LESSON:** Decision makers should consider the character of the conservation area when determining planning applications. Here the inappropriate materials, detailing and site layout have introduced an uncharacteristic bland development in one of the strongest parts of the conservation area.

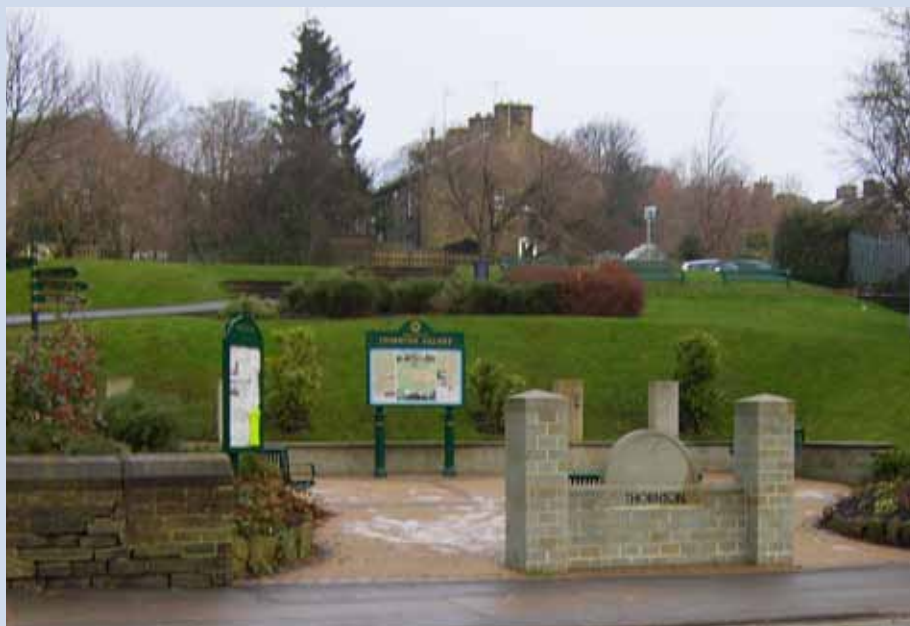
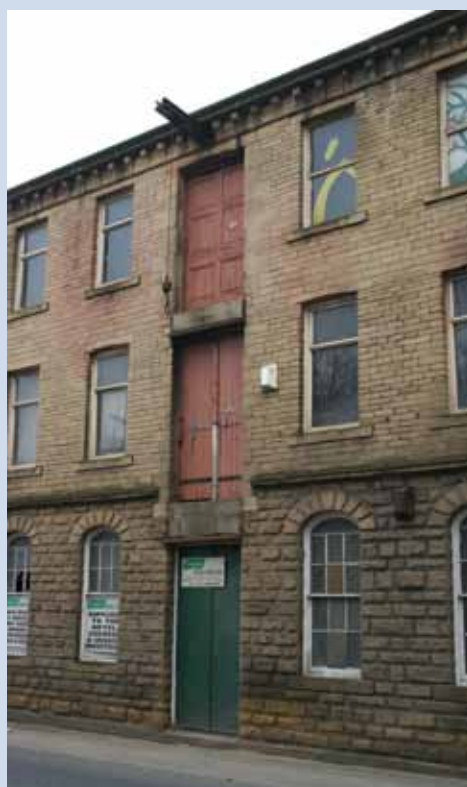
Prospect Mill, Thornton Road

- 5 Bridge Street;
- 1 Market Street / 2 Green Lane;
- 2-4 Market Street;
- 33a Market Street;
- 39 Market Street;
- 46 Market Street;
- Prospect Mills, Thornton Road;
- 482 Thornton Road (shop unit only).

The prolonged vacancy or underuse of these buildings makes their longer term future uncertain, and presents an atmosphere of neglect in the place. The conservation area would benefit if these buildings were returned to use.
