Conservation Area Appraisal

# Steeton

**April 2008**

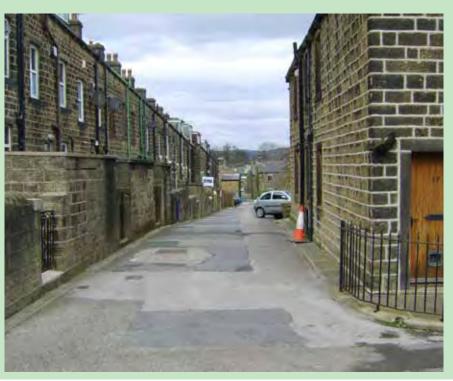
Clockwise from top left: The view across the valley to Silsden contributes to the sense of place in the conservation area. Uniform terraces such as Queen Street were mostly built for mill workers in the village. Holme House, Skipton Road is considered to be a key unlisted building in the conservation area.

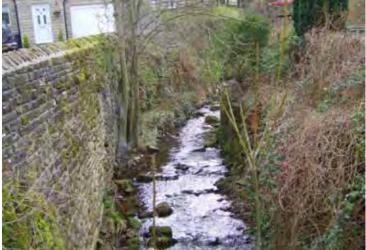
Clockwise from top left: Steep topography creates interesting vistas up to Falcon Cliffe. Historically Steeton beck has been important to the development of the settlement. Woodlands Mill is an important part of Steeton's industrial heritage. 13, Keighley Road retains many good period details.

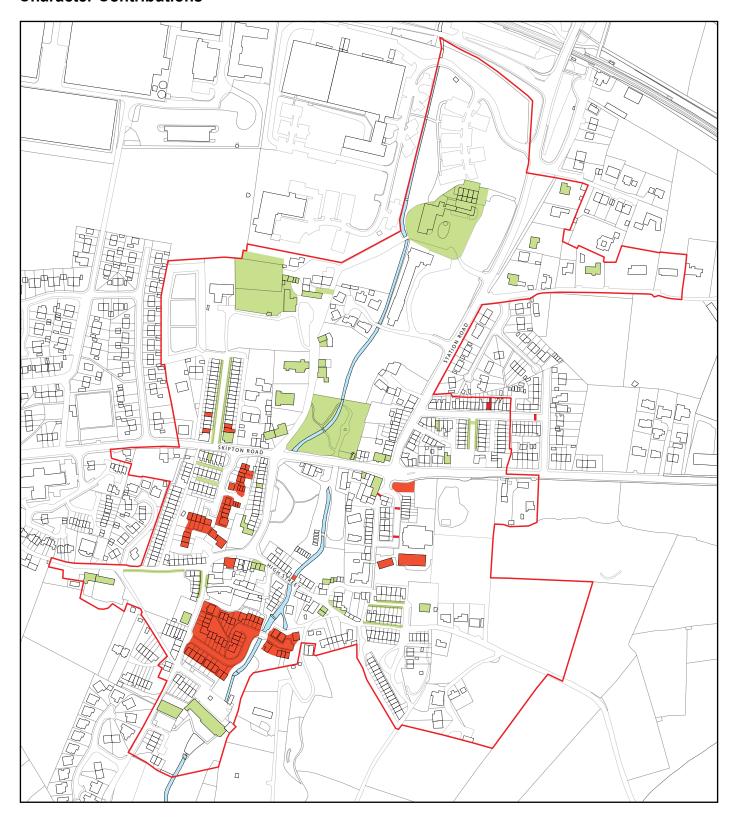
### **Character Contributions**

NB The 'positive', 'negative' and 'neutral' areas relate to the contribution the site/building currently makes to the character of the Conservation Area. The classification in no way means that the site/building has no special architectural, historic or archaelogical interest.

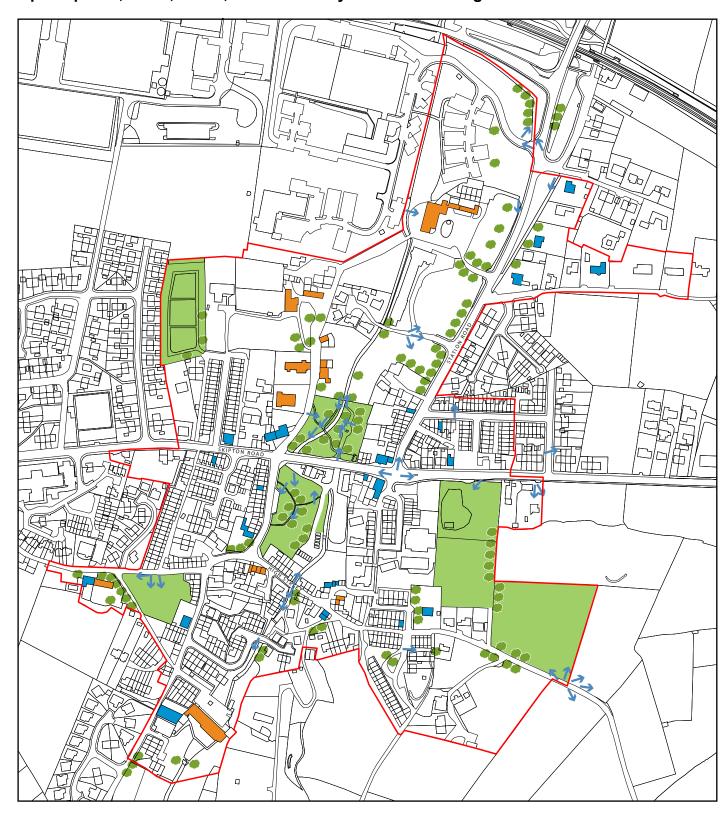
## Open Spaces, Trees, Views, Listed and Key Unlisted Buildings

Conservation Area Boundary Key open space Important tree(s)

Key view or vista

NB This map does not identify key trees individually, but merely indicates where there is at least one important tree.

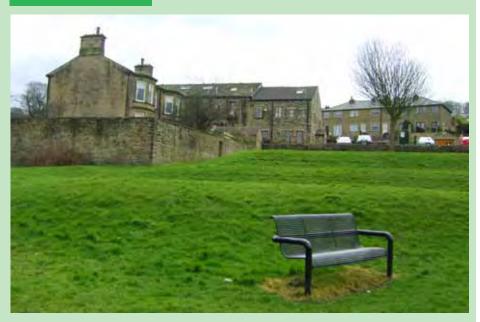
Three trees of amenity or townscape value have been lost in the conservation area since the publication of the conservation area assessment.

### **NEUTRAL CHANGE**

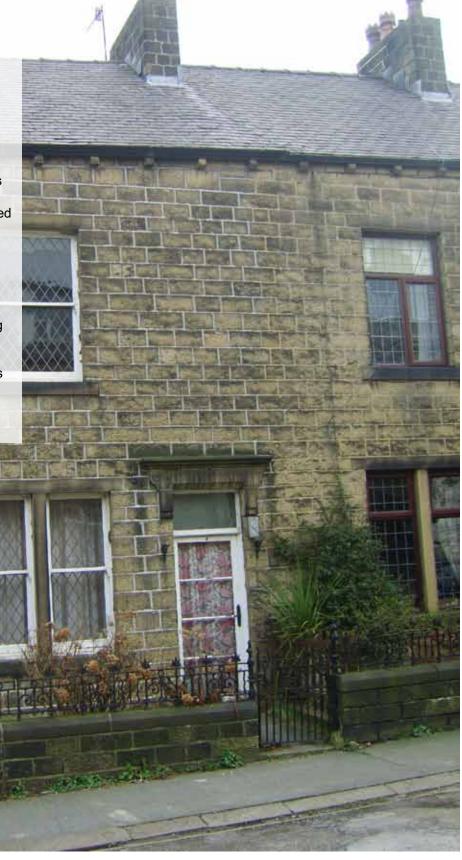
As part of the review of the conservation area a number of properties displaying inappropriate alterations and additions have been noted.

Whilst a minority are considered to have a severely negative impact on the character of the conservation area, there are a number of properties displaying relatively minor visual detractors, such as reduced or removed chimneys, inappropriate rainwater goods, painted or inappropriately pointed elevations and modern windows and doors. The Council will look to ways of mitigating these works and will actively discourage the occurrence of similar situations arising within the conservation area in the future. Design guidance on the repair and maintenance of historic properties has recently been published and is available on the Council's website at www.bradford.gov.uk/repairs.
