Conservation Area Appraisal

Goitside

September 2007

City of Bradford MDC

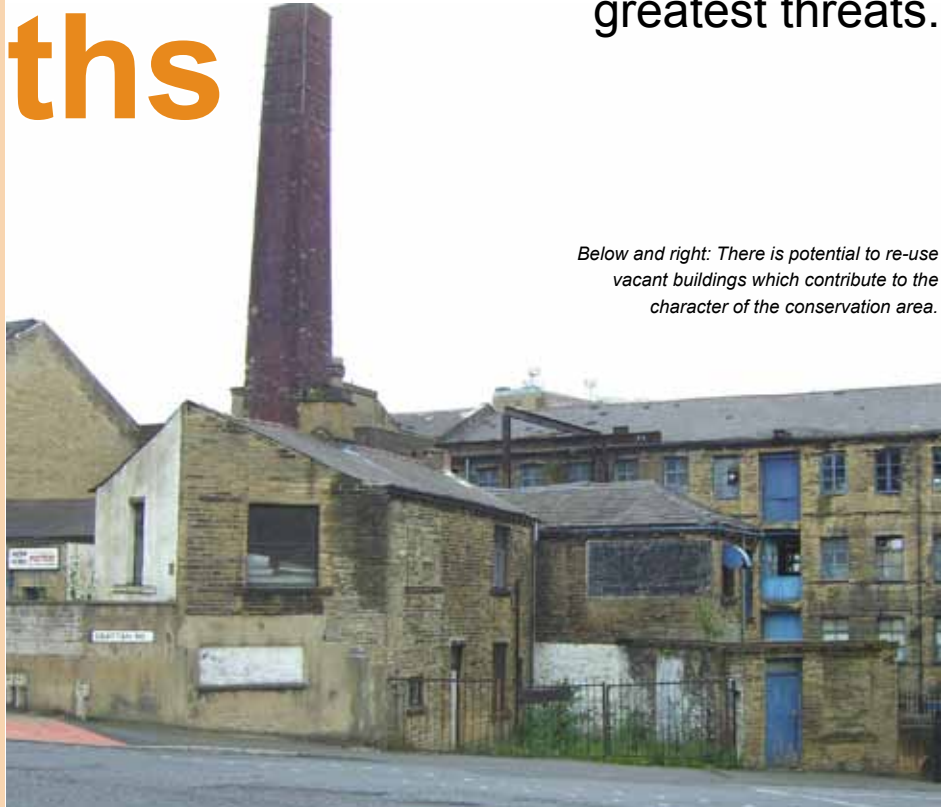
Below and right: There is potential to re-use vacant buildings which contribute to the character of the conservation area.

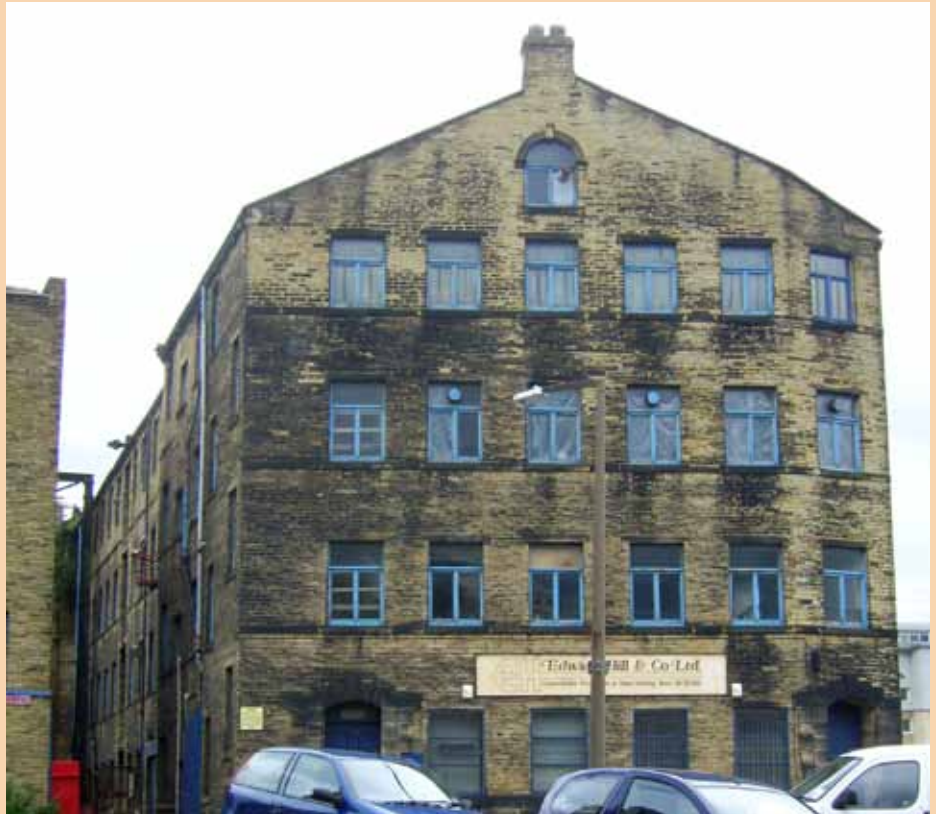
*Typical textile mill on Lower Grattan Road.
Buildings of this scale are the dominant
elements of the area*

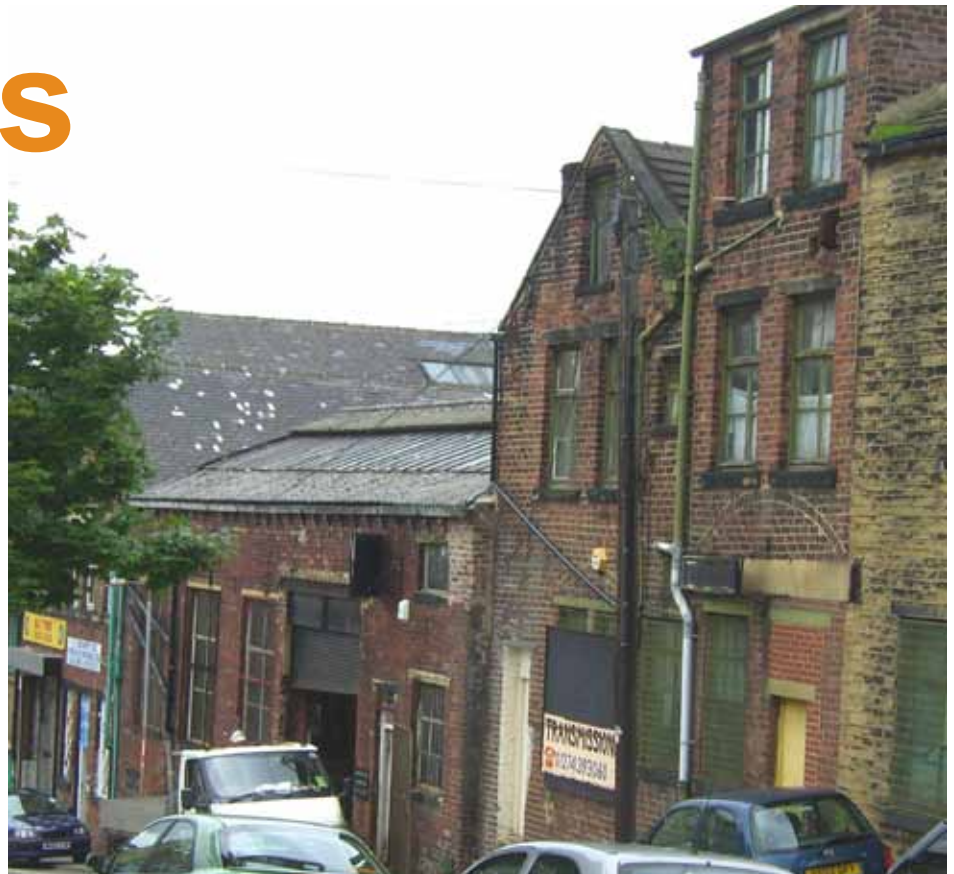
Less dominant and dignified buildings still contribute to the informal and varied composition of the area so can offer renovation opportunities

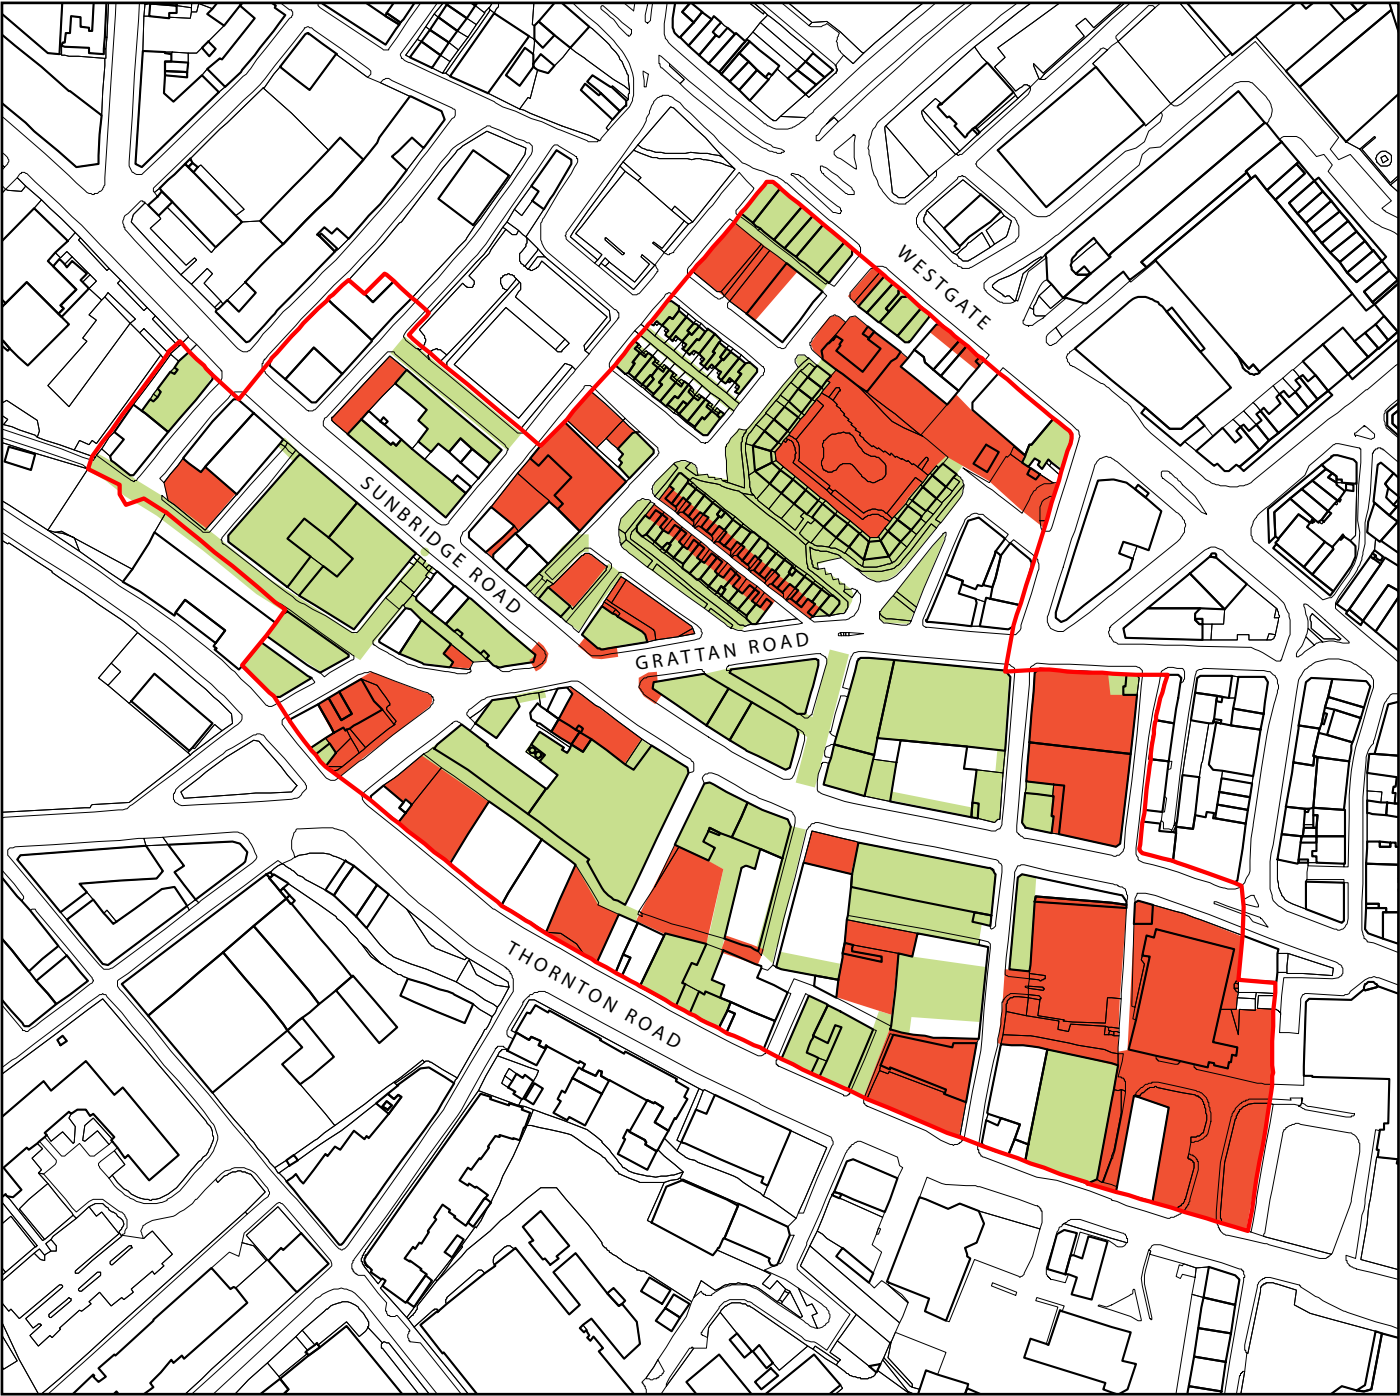
Character Contributions

- Conservation Area Boundary
- Areas providing a **positive** contribution to character
- Areas providing a **negative** contribution to character
- Areas providing a **neutral** contribution to character

NB The 'positive', 'negative' and 'neutral' areas relate to the contribution the site/building currently makes to the character of the Conservation Area. The classification in no way means that the site/building has no special architectural, historic or archaeological interest.

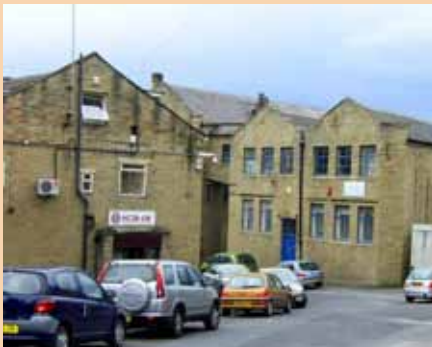
156-158 Grattan Road has returned to a full commercial / industrial use. The works to the building have had a positive impact on the external appearance of the building.

POSITIVE CHANGE

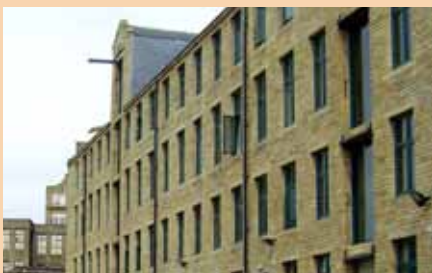
Colonial Buildings, Sunbridge Road has been converted to dwellings. The conversion respects the industrial character of this Listed Building.

POSITIVE CHANGE

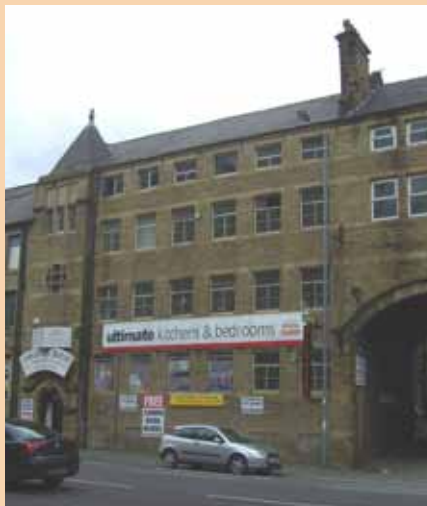
The retail occupier of **114 Thornton Road** has added inappropriate new signs, including a fascia sign to the front elevation building without advertisement consent.

NEGATIVE CHANGE

LESSON: Building owners or occupiers must apply for advertisement consent for new signage and planning permission for any shopfront alterations. In this instance, the Council would be within its powers to undertake enforcement action.

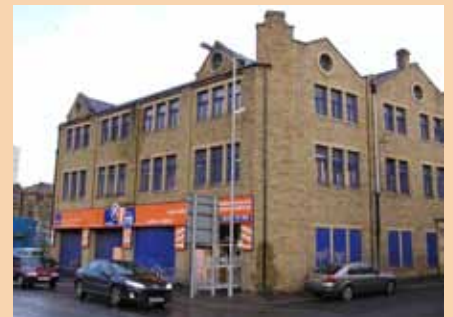
The large disused commercial building at **158 Thornton Road** has returned to use as a large shop. While the return to a viable use and the retention of traditional door and window details is welcomed, the inappropriate fascia signage and other signage harms the character and appearance of the conservation area.

**POSITIVE CHANGE /
NEGATIVE CHANGE**

LESSON: Building owners or occupiers must apply for advertisement consent for new signage and planning permission for any shopfront alterations. In this instance, the Council would be within its powers to undertake enforcement action.

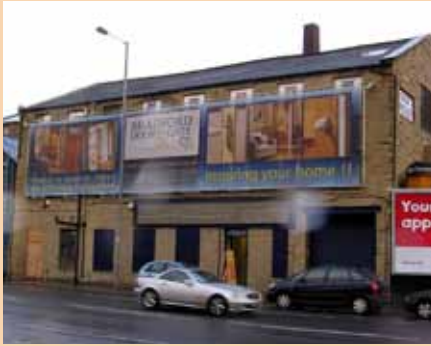
The retail occupier of **138-140 Thornton Road** has added inappropriate new signs to the building without advertisement consent. The signs include a fascia at ground floor and a two storey high banner sign which almost runs the full width of the building.

NEGATIVE CHANGE

LESSON: Building owners or occupiers must apply for advertisement consent for new signage and planning permission for any shopfront alterations. In this instance, the Council would be within its powers to undertake enforcement action.

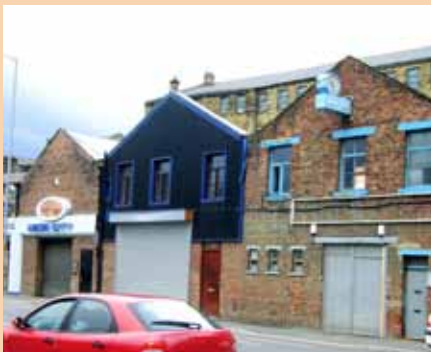
The front elevation of the commercial building at **142 Thornton Road** has been partially re-clad in rolled metal and a solid roller shutter installed over its front vehicle entrance without planning permission. These alterations detract from the building's character and appearance.

NEGATIVE CHANGE

LESSON: Building owners or occupiers must apply for planning permission if they intend to carry out alterations such as these. In this instance, the Council would be within its powers to undertake enforcement action.

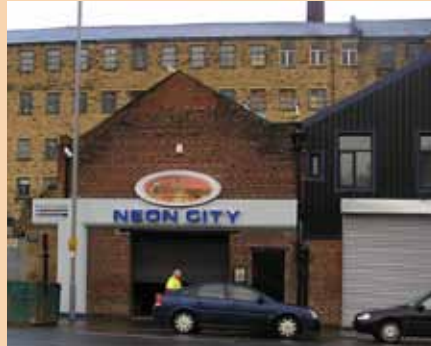
New signage has been attached to the front of **144 Thornton Road** without advertisement consent. Elements of the signage detract from the character and appearance of the building.

NEGATIVE CHANGE

LESSON: Building owners or occupiers must apply for advertisement consent for new signage and planning permission for any shopfront alterations. In this instance, the Council would be within its powers to undertake enforcement action.

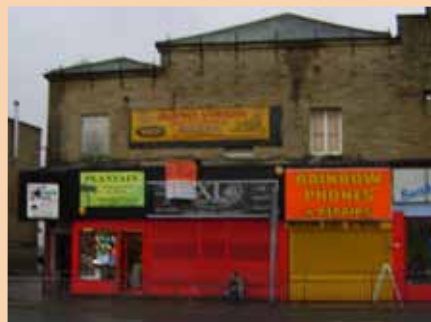
The shopfronts and signage of the three different shops at **49, 53 and 55 Westgate** have been replaced with inappropriate modern style details, incorporating a rollershutter without planning permission or advertisement consent.

NEGATIVE CHANGES

LESSON: Replacement shopfronts and rollershutters require planning permission. Building owners or occupiers should check with the Council when permission is needed. Any new or replacement signage requires advertisement consent. In these cases the Council would be within its powers to carry out enforcement action against the unauthorised works and signage.

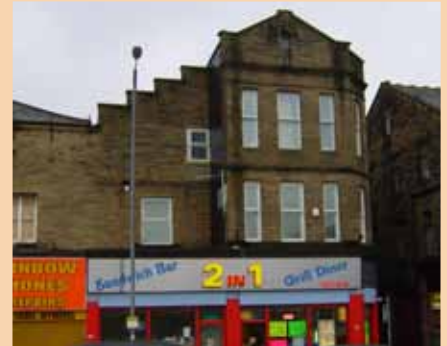
The underused upper floors of **57 - 59 Westgate** were granted planning permission for conversion to flats. The permission returns the building to full use, retains traditional sash windows, and occasioned the removal of a billboard from the side of the building.

POSITIVE CHANGE

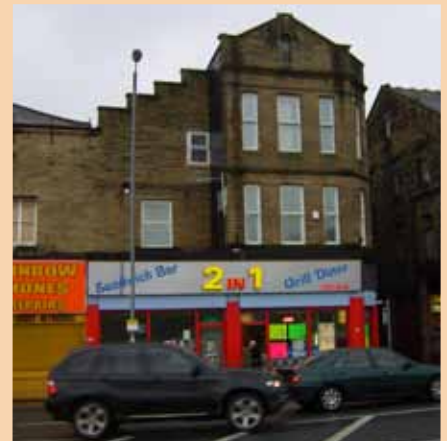
The shopfront and signage of the take-away at **57-59 Westgate** are unauthorised inappropriate modern style details, incorporating a rollershutter without planning permission or advertisement consent.

NEGATIVE CHANGE

LESSON: Replacement shopfronts and rollershutters require planning permission. Building owners or occupiers should check with the Council when permission is needed. Any new or replacement signage requires advertisement consent. In this case the Council would be within its powers to carry out enforcement action against the unauthorised works and signage.

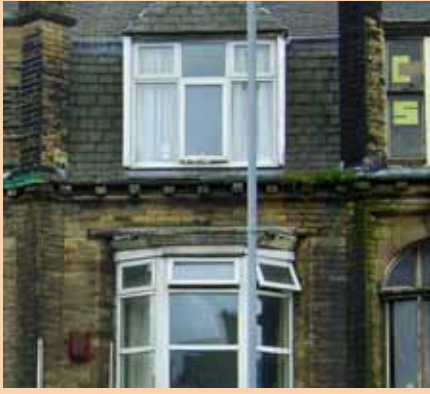
Planning permission was granted in 2003 for the conversion of the upper floors of **65 Westgate** to a self-contained flat. While this is an appropriate re-use of the upper floors, the original timber windows to the upper floors have been replaced with inappropriate uPVC, which has a negative effect on the character and appearance of the parade of shops.

NEGATIVE CHANGE

LESSON: Replacing the windows of flats requires planning permission. Building owners should check with the Council before works such as this are undertaken. In this case, the Council would be within its powers to carry out enforcement action against the unauthorised works.
