Conservation Area Appraisal

## North Park Road

**November 2007**

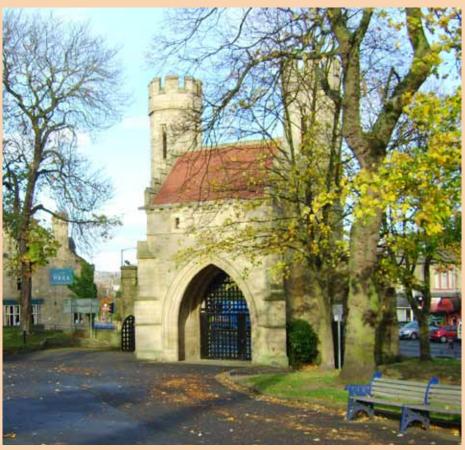
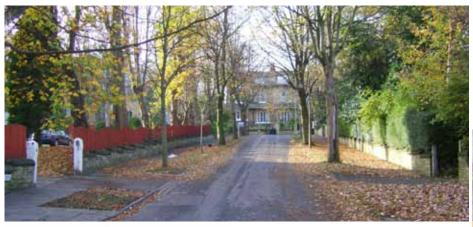
Anti-clockwise from top: A pitched roof dormer with all original details. Ashburnham Road with its villas and tree lined avenue. Decorative bargeboards retained. A large villa property with most original features retained such as chimney, windows and rainwater goods.

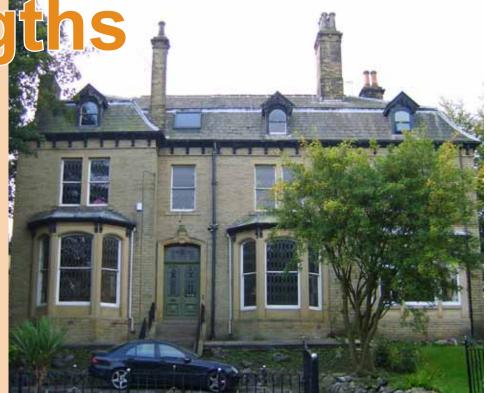
Top: Victorian villas styled property retains most of its original features. Above: Lister Park with its large tree avenue.

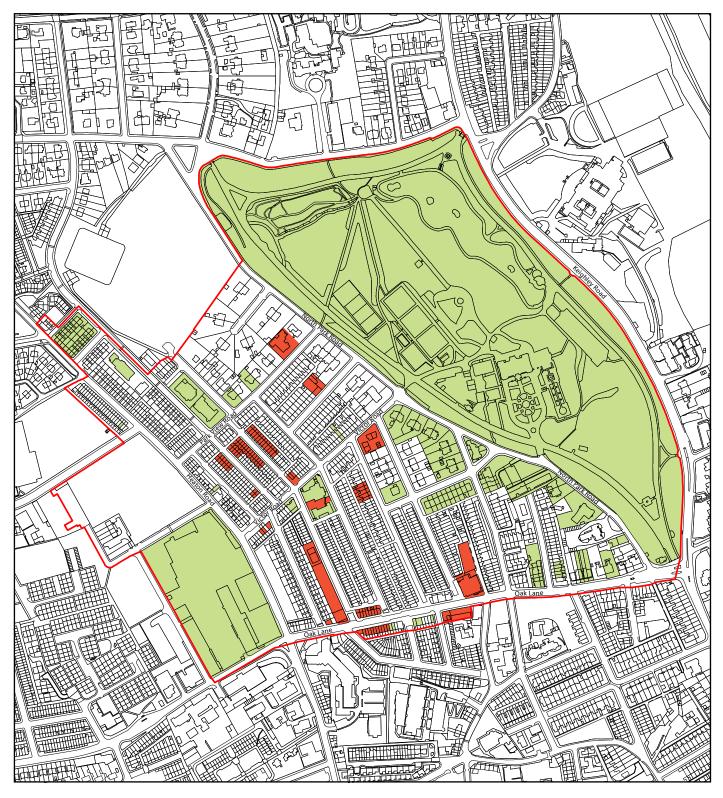
### **Character Contributions**

NB The 'positive', 'negative' and 'neutral' areas relate to the contribution the site/building currently makes to the character of the Conservation Area. The classification in no way means that the site/building has no special architectural, historic or archaelogical interest.

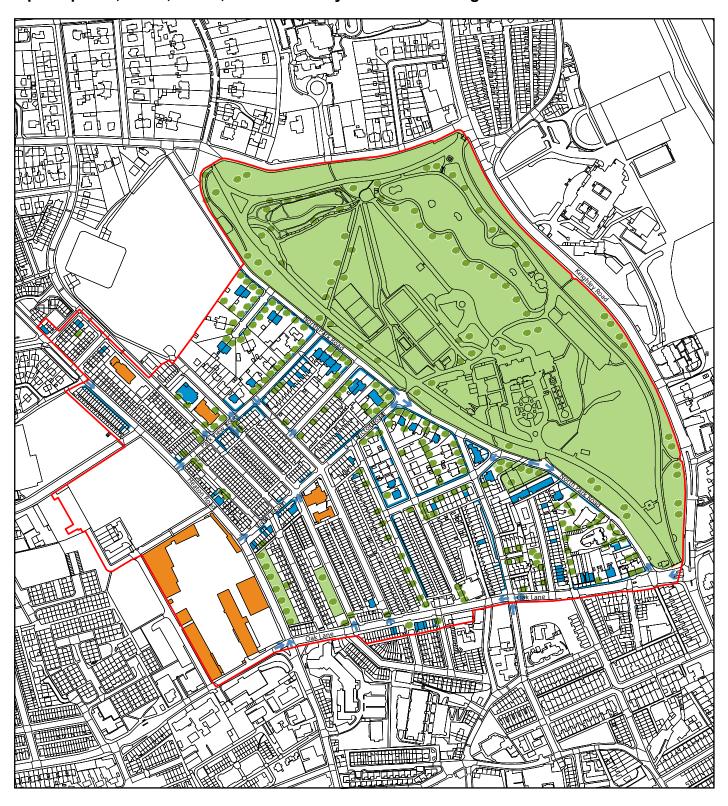
Open Spaces, Trees, Views, Listed and Key Unlisted Buildings

NB This map does not identify key trees individually, but merely indicates where there is at least one important tree.

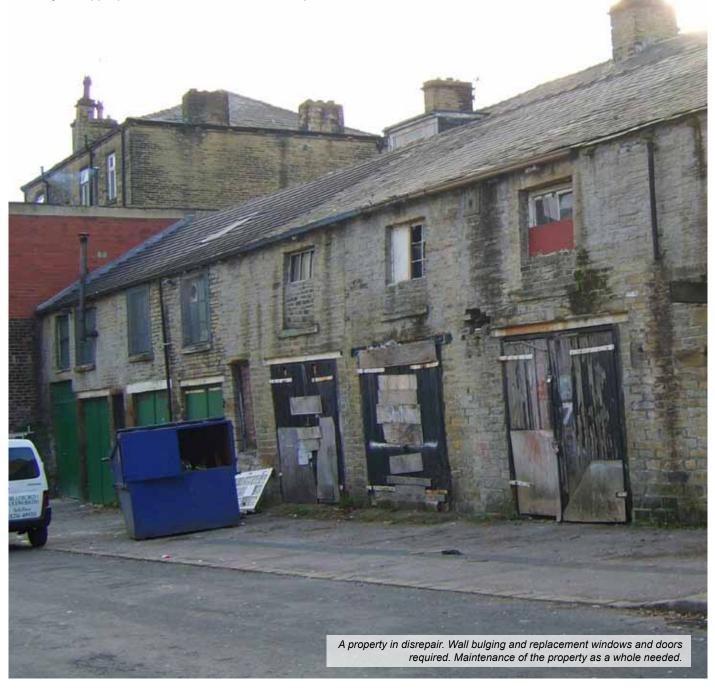
As part of the review of the conservation area a number of properties displaying inappropriate alterations and additions have been noted. Whilst a minority are considered to have a severely negative impact on the character of the conservation area, there are a number of properties displaying relatively minor visual detractors, such as reduced or removed chimneys, inappropriate dormer

windows, painted or inappropriately pointed elevations, modern windows and doors, removed or inappropriate boundary features, inappropriate fascia signage, and poorly detailed shopfronts. The Council will look to ways of mitigating these works and will actively discourage the occurrence of similar situations arising within the conservation area in the future. Design guidance on the repair and maintenance of

historic properties has recently been published and is available on the Council's website at www.bradford. gov.uk/repairs
