Conservation Area Appraisal

Little Horton Lane

January 2008

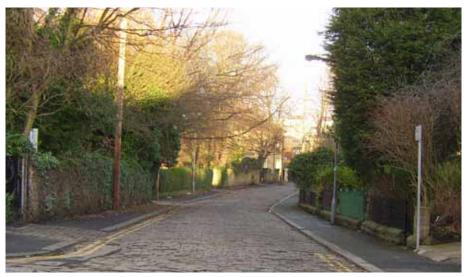
View down Russell Street, it retains its original cobbled setts

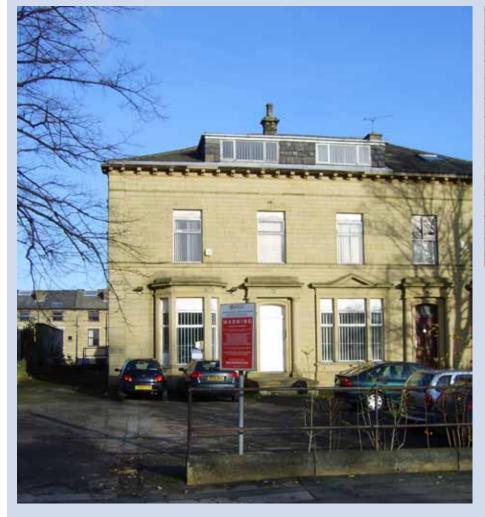
Top: Traditional sash windows can be seen throughout Little Horton.

Above: Detailed stonework is a common feature throughout Little Horton conservation

Left: Many of the larger properties have become offices seeing their front gardens change to parking areas.

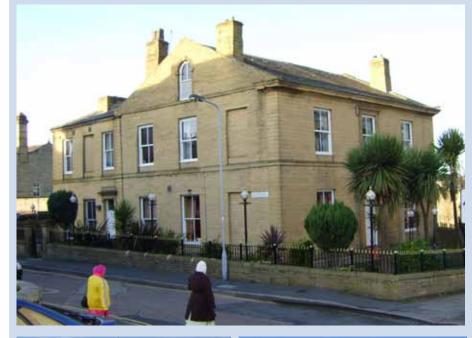
Top right: A good example of traditional windows

Far right: 41, Pemberton Drive is a good example of a property retaining a large nuber of traditional details e.g. bargeboards, full height chimneys.

Right: Trinity Baptist Church is a grade II listed church in the conservation area.

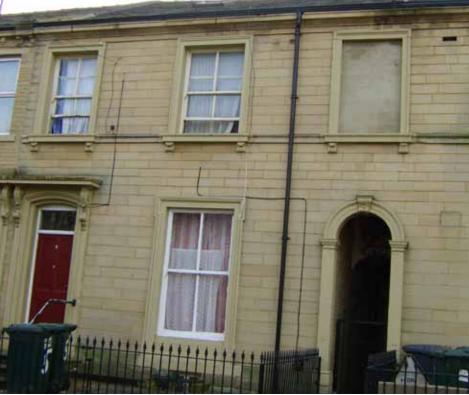
Number 5, Howard Street retains a high number of traditional details

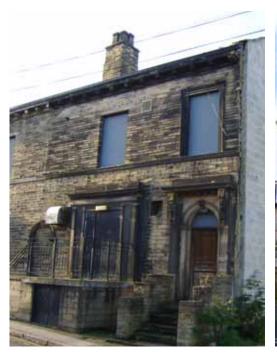
Far left: Neglected vacant building has a negative impact on the character of the conservation area.

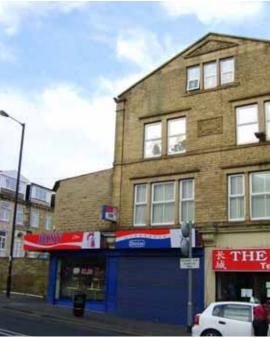
Left: Rollershutters left down during the day have a negative impact on the character of the conservation area

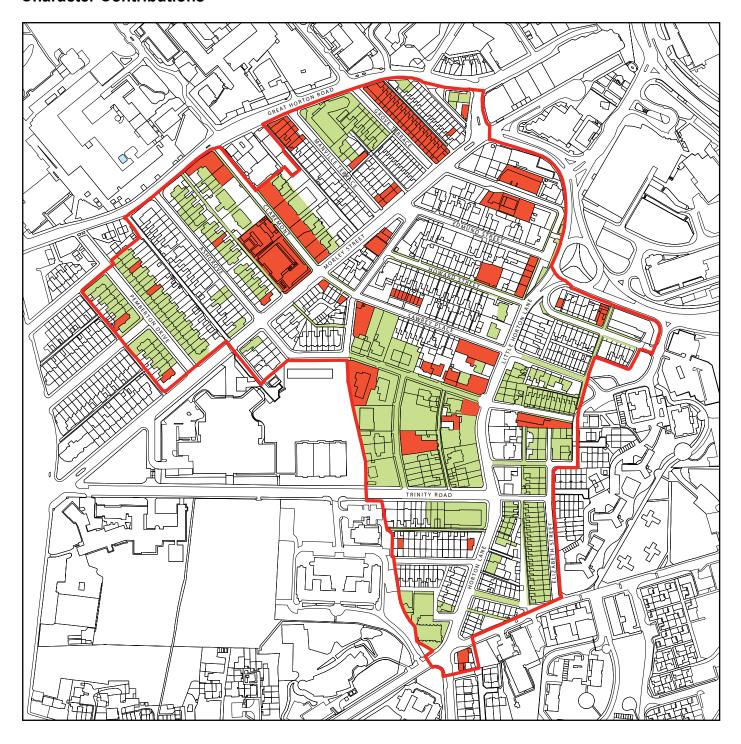
Character Contributions

NB The 'positive', 'negative' and 'neutral' areas relate to the contribution the site/building currently makes to the character of the Conservation Area. The classification in no way means that the site/building has no special architectural, historic or archaelogical interest.

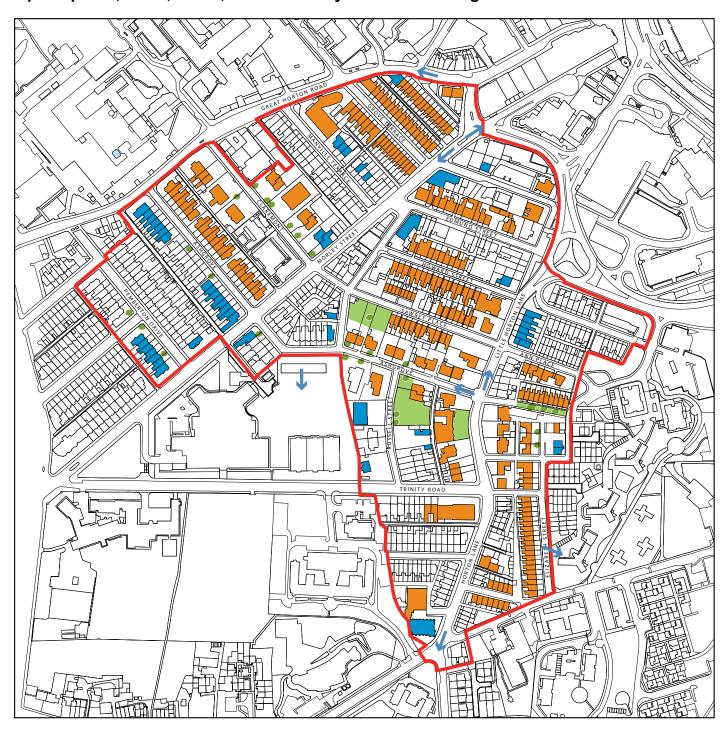
Open Spaces, Trees, Views, Listed and Key Unlisted Buildings

NB This map does not identify key trees individually, but merely indicates where there is at least one important tree.
