Conservation Area Appraisal

Addingham

JULY 2007

City of Bradford MDC

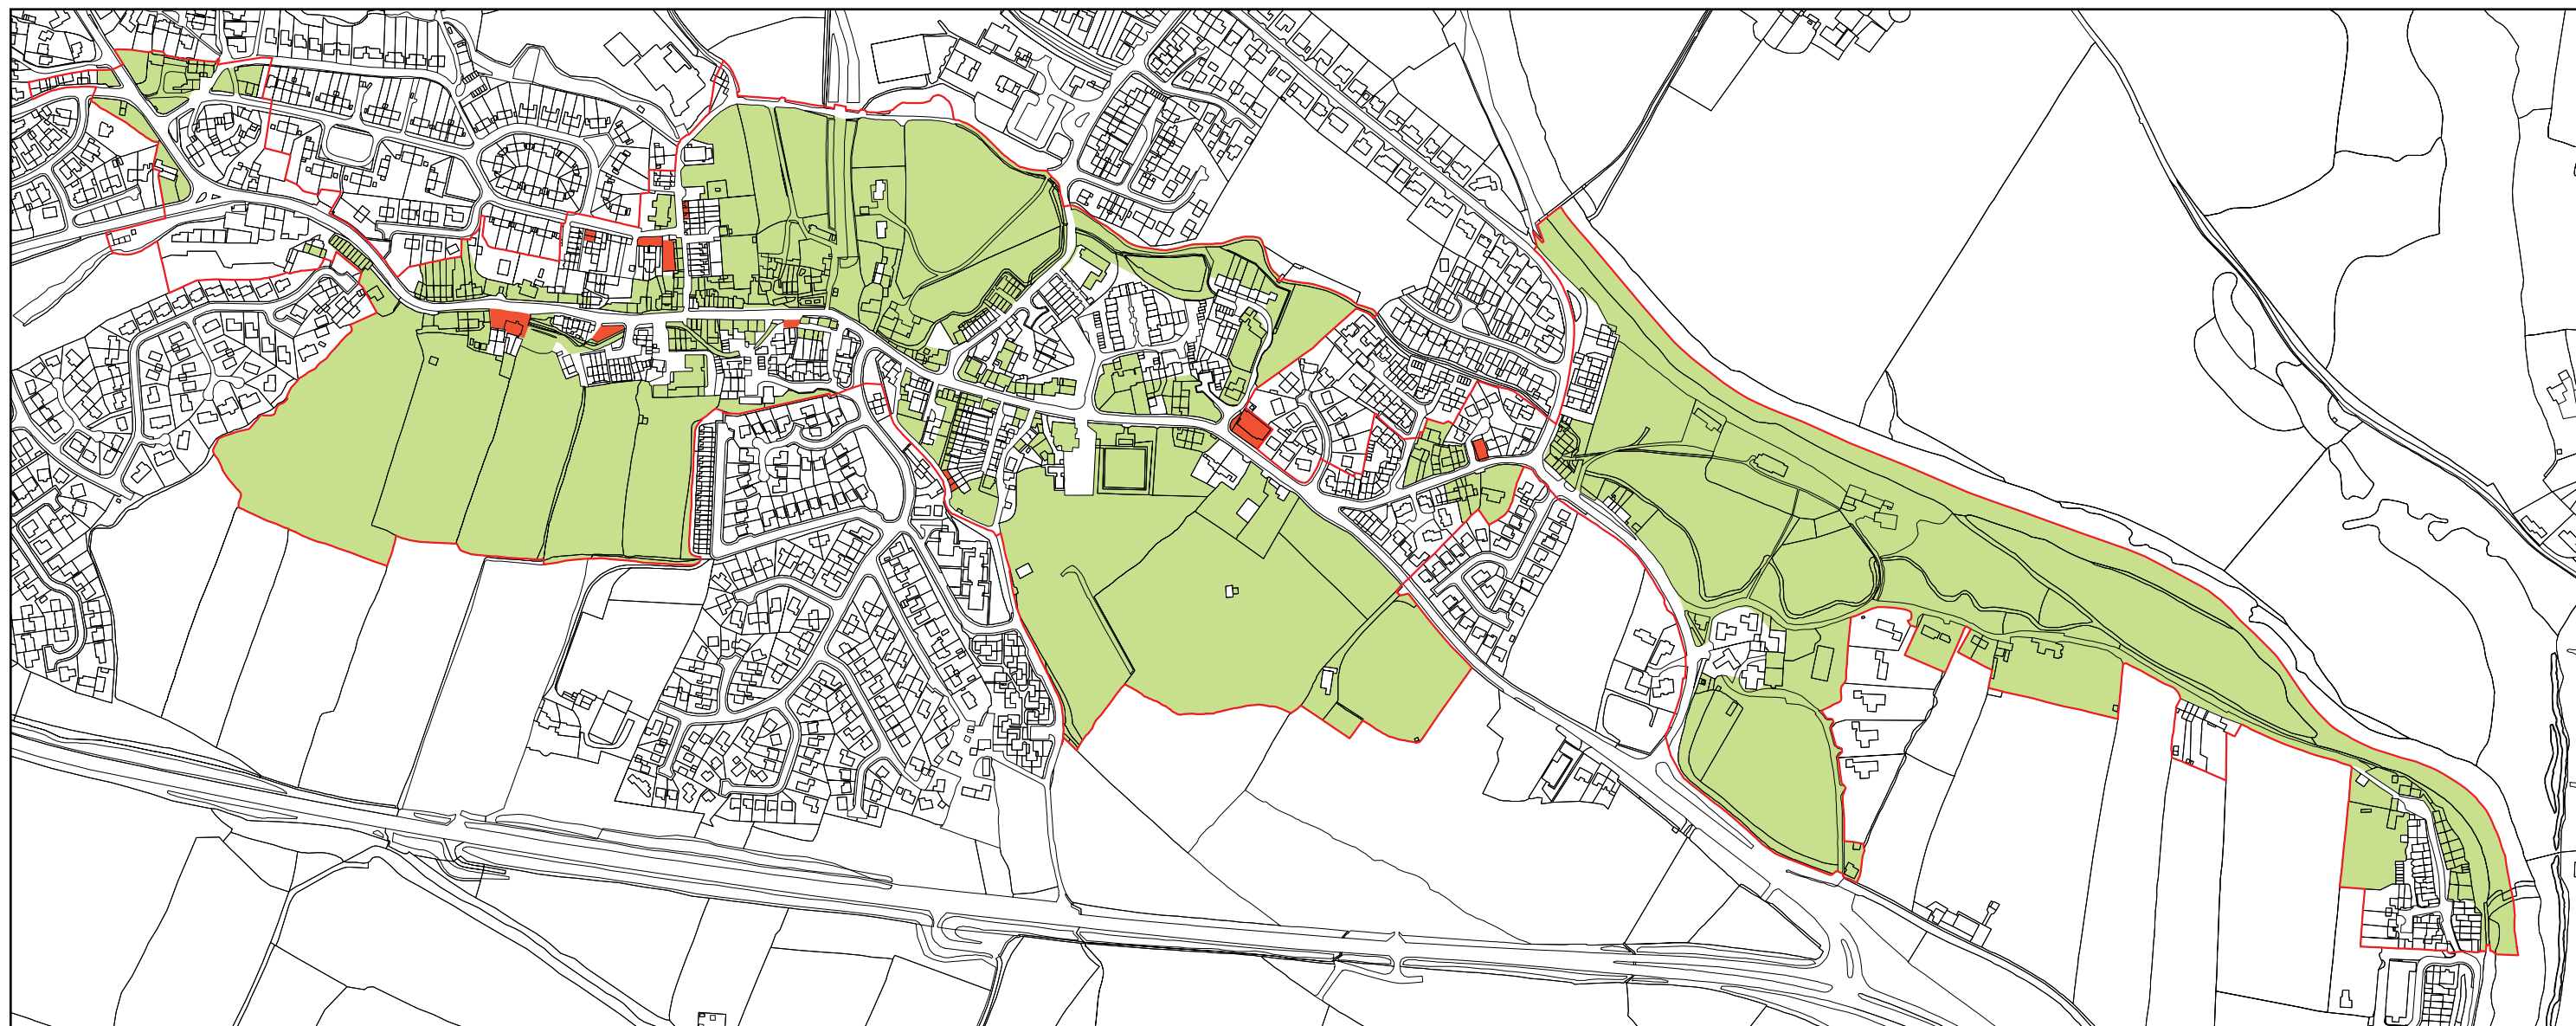
Character Contributions

NB The 'positive', 'negative' and 'neutral' areas relate to the contribution the site/building currently makes to the character of the Conservation Area. The classification in no way means that the site/building has no special architectural, historic or archaeological interest.

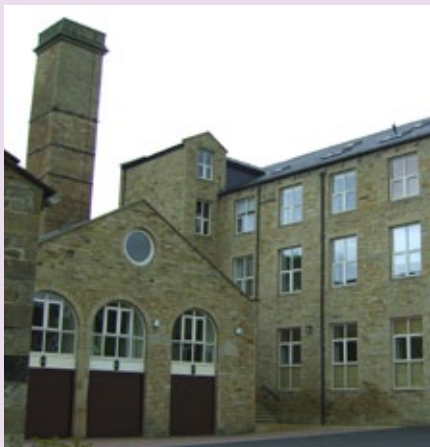
Burnside Mill has been successfully converted to apartments and retains much of its pre-conversion character and appearance

POSITIVE CHANGE

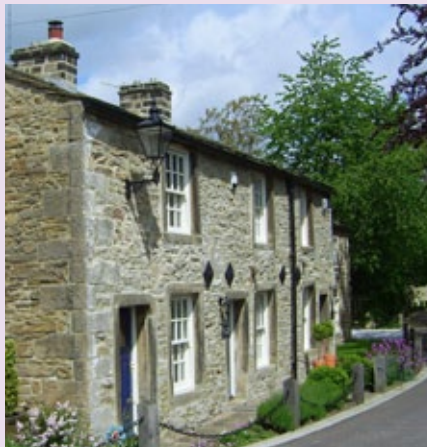
The cottages at **1 and 1a Saw Mill Lane** have been refurbished, altered and extended. The cottages retain their traditional character, while the extension is suitably subservient and complementary to the cottages

POSITIVE CHANGE

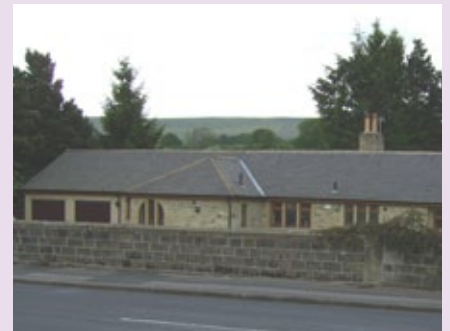
The modern bungalow at **157a-157b Main Street** has recently been extended in a sympathetic manner using appropriate materials.

NEUTRAL CHANGE

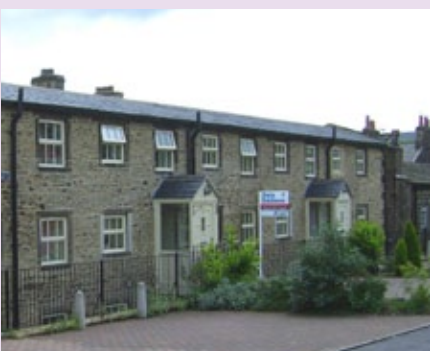
The Grade II Listed former mill at School Lane, which was vacant, neglected and had an asbestos roof, has been converted to three dwellings and named The Old Weaving Shed. The conversion has returned the building to full use and introduced a traditional slate roof. However, details such as the positions of former loading doors have been lost, while landscaping, porch and window details could be more appropriate to the building.

POSITIVE/NEUTRAL CHANGE

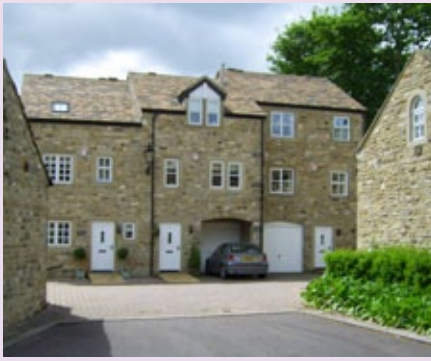
The former sawmill at Saw Mill Lane was undergoing conversion and rebuilding to residential, with some new build at the time of the previous survey of the conservation area. The former mill has virtually been rebuilt and looks less like a traditional industrial building but rather domestic, particularly with the lower attached row of houses with twee detailing. The new build block is generally appropriate, but like the rest of this scheme, could have more appropriate details, particularly in terms of fenestration and windows.

NEUTRAL CHANGE

LESSON: The finer details can have a significant bearing on the overall impact of a new development. While this development is attractive, more care should have been taken by the planning authority and developer to ensure a high quality which is also appropriate to the conservation area.

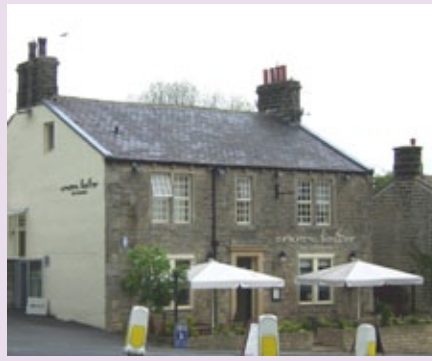
In 2005 Planning Permission was refused for replacement windows and permanently sited 'jumbrella' canopies to the front of the **Craven Heifer, Main Street**. Despite this the work has already been carried out. While the new mullioned windows are an improvement to the building, the permanent canopies in front of the pub clutter the street scene.

POSITIVE/NEGATIVE CHANGE

LESSON: Property owners need to obtain planning permission prior to works commencing. In this case the Council would be within its powers to undertake enforcement action, as none of the works have permission.

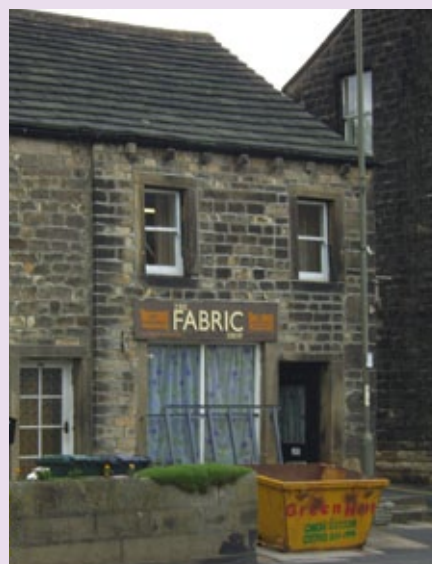
The occupier of the shop at **84 Main Street** changed in 2007. The alterations to the shopfront have removed an out of scale fascia with appropriate signage and retains the traditional features and details of the shopfront and building.

POSITIVE CHANGE

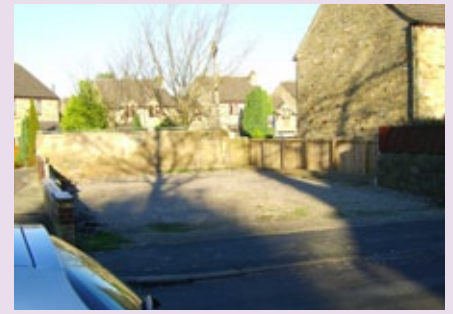
The small, semi derelict workshop at **21 Church Street** was demolished in 2004 without Conservation Area Consent. The site remains cleared and no valid applications for the site's redevelopment have been received.

NEGATIVE CHANGE

LESSON: Even if a building in a conservation area is derelict, Conservation Area Consent is required for its demolition. Property owners and the Council's Building Control service should be aware of this. A planning application for the site's redevelopment should accompany the Conservation Area Consent application in order to prevent the site being the unused eyesore that it presently is.

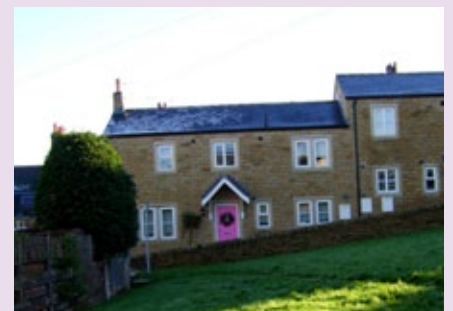
In 2004 Planning Permission was granted to replace the two garages on the mainly previously undeveloped site at **Lodge Hill** with two houses, which have recently been completed. The massing, materials and positioning of the houses are appropriate to the area and maintain the open character of much of the site. However, detailing in terms of windows, window sizes, porches, vents and flues lets the scheme down, as does the timber fencing to the rear of one of the dwellings.

NEUTRAL CHANGE

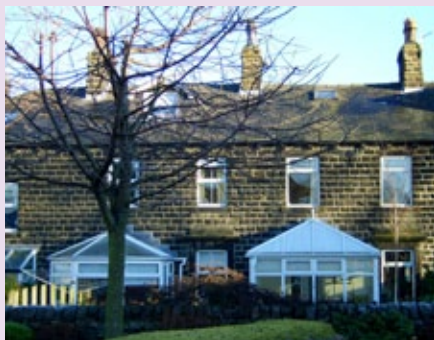
A uPVC conservatory has recently been built on the front elevation of **4 Cragg View**, similar to those already built at nos 2 and 8. Although these conservatories do not need planning permission to be built, their design, height, massing and materials mean that they collectively have a strongly negative impact on the traditional appearance of the terrace.

NEGATIVE CHANGE

LESSON: Where alterations and extensions do not require planning permission, homeowners should consider the impact of their works on the special character and appearance of their conservation area. The Design and Conservation Team would be happy to advise.

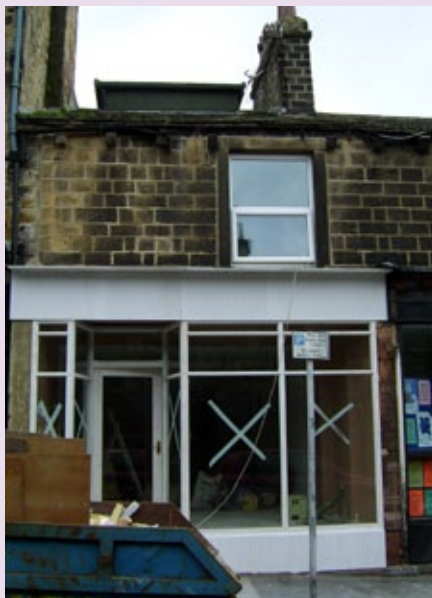
The shop at **98 Main Street** was damaged by fire. The traditional shopfront and upstairs window have been removed and work has commenced at replacing these without planning permission. The Council's Planning Enforcement Team and the Design and Conservation Team are currently working with the owner to ensure that traditional details are reinstated. The building is currently vacant.

NEUTRAL/NEGATIVE CHANGE

LESSON: Even after unexpected events such as fires, the planning process has a part to play in rebuilding or altering buildings and property owners should make the Planning Service aware of their activities. In this case, putting right of the unauthorised changes is already in hand.

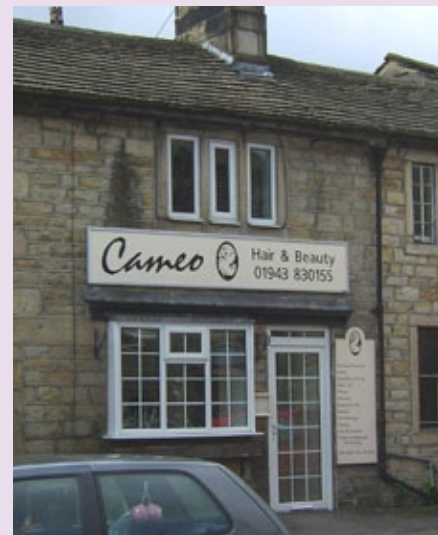
The Dutch awning at the shop at **129 Main Street** has been removed and replaced with a large fascia sign without Advertisement Consent. The new sign detracts from the street scene.

NEGATIVE CHANGE

LESSON: Advertisement Consent is required for new shop signage and in conservation areas it should respect the area's special character. In this case the Council would be within its powers to undertake enforcement action.
